2006 27ft Boston Whaler Challenger
Powered by twin 2016 Yamaha 300 Outboards

Vessel MH-1 Purchased in 2006

Current condition of MH-1

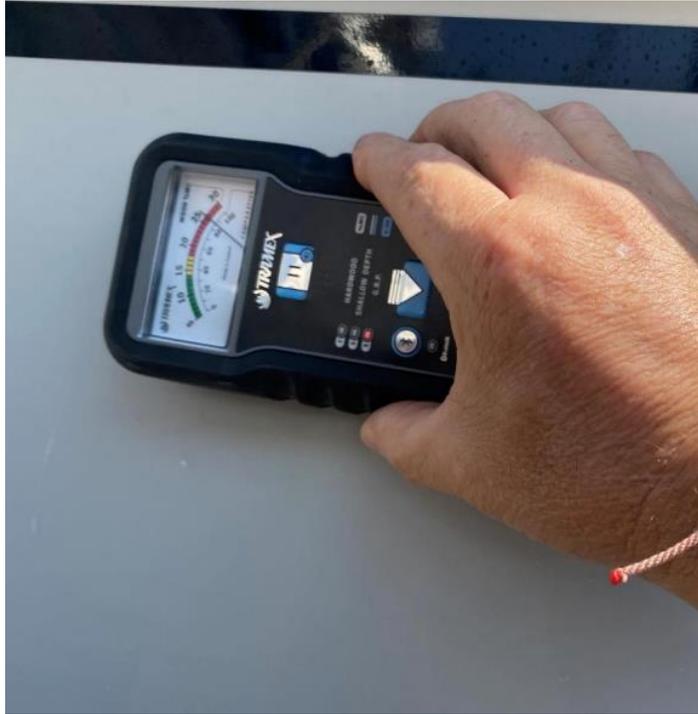
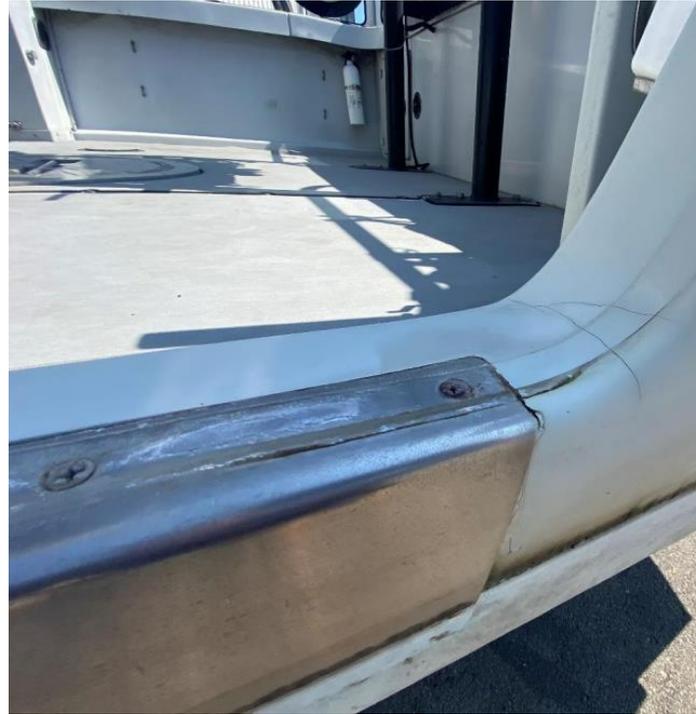
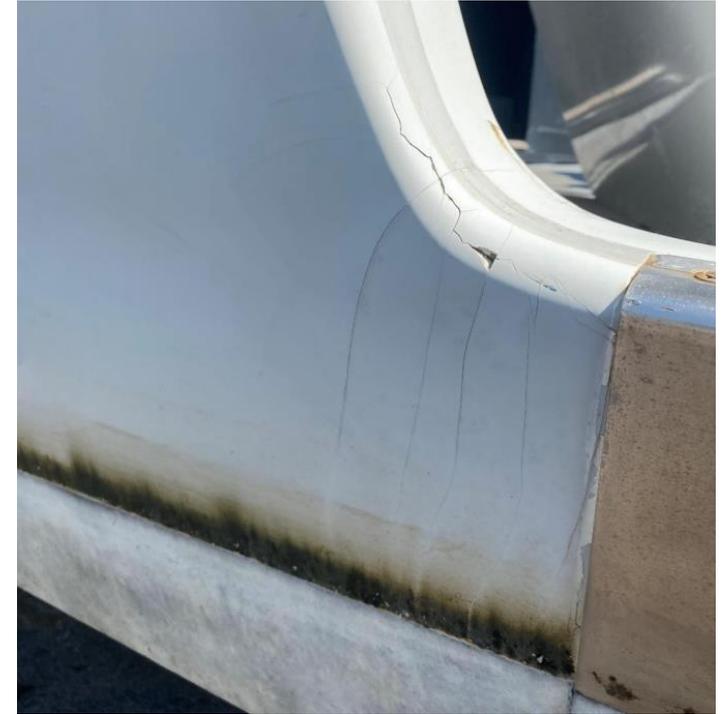
Delamination and severe cracking at the dive door

- The delamination and cracking resulted in the hull being saturated with water. This photo represents the amount of moisture measured on the port side of the vessel.

The vessel hull, on the port side, is saturated with moisture and the hull skin is delaminated from the foam core. Around the boarding door has heavy gelcoat cracking, crazing, and delamination from years of the hull flexing.

The damage found is common in a vessel used in this service for over 15 years, and is not cost effective to repair. That, compounded with the outboard engines reaching the end of their useful life of 1,000 hours, finds the vessel not fit for its service as the primary harbormaster/rescue vessel for the town of Marion, MA.

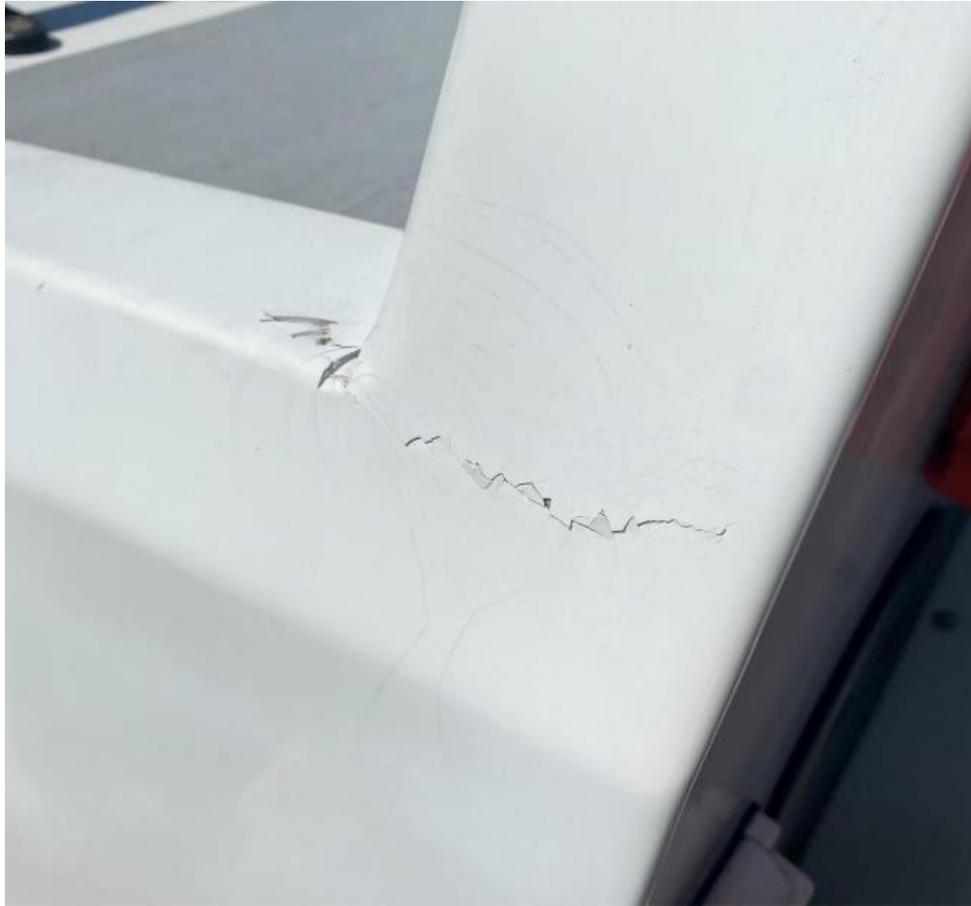
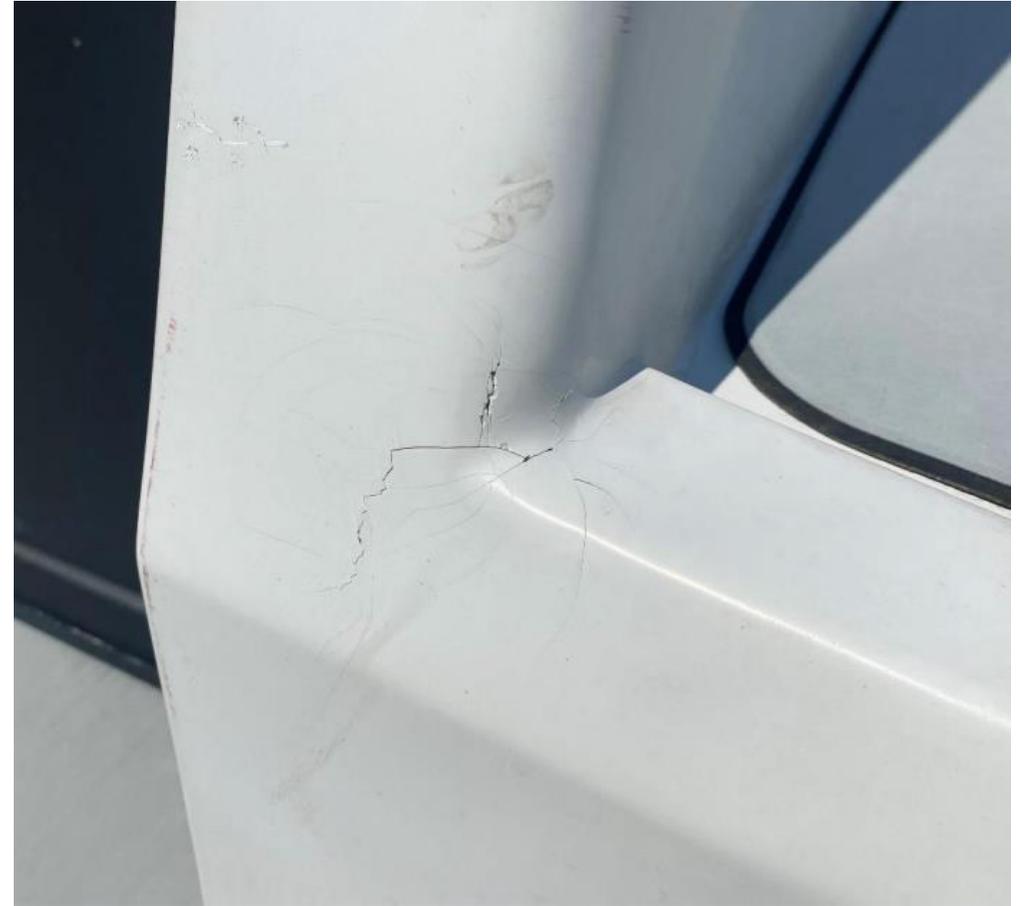
Cracking on the Port and Starboard side of the wheelhouse

This flexing of the hull has caused delamination of the superstructure to the hull joint on the aft port and starboard sides. There is also flexing and delamination to the head liner on the interior of the vessel.

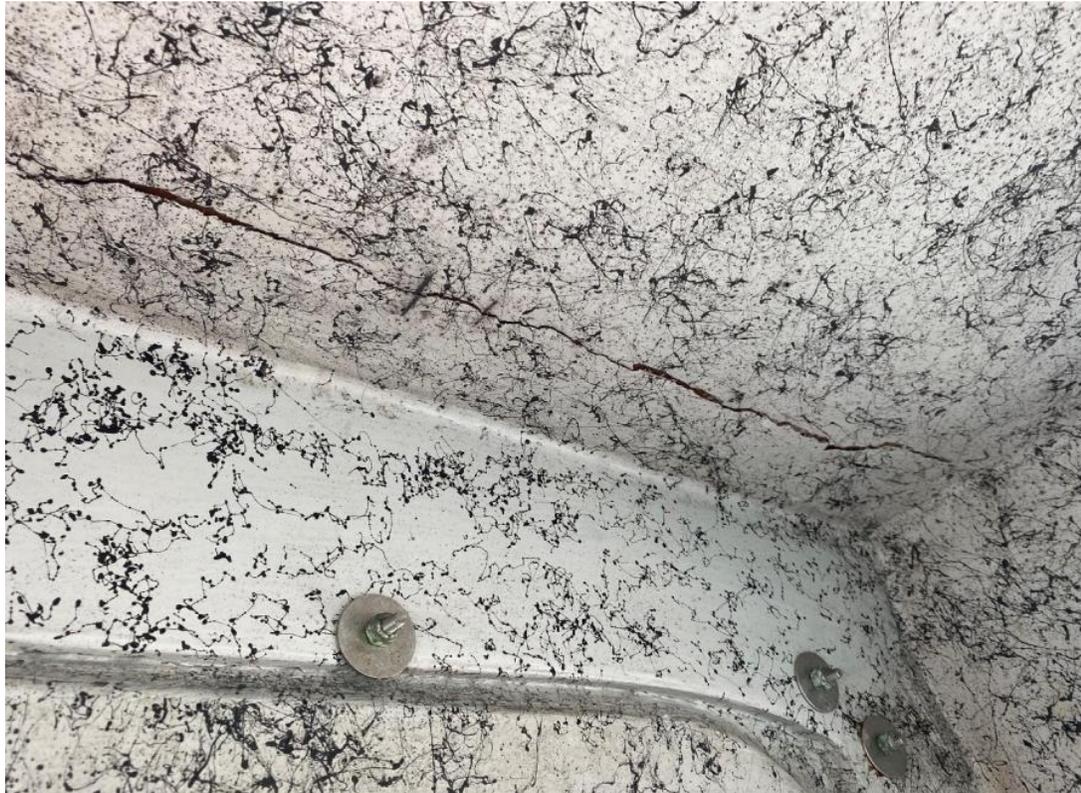
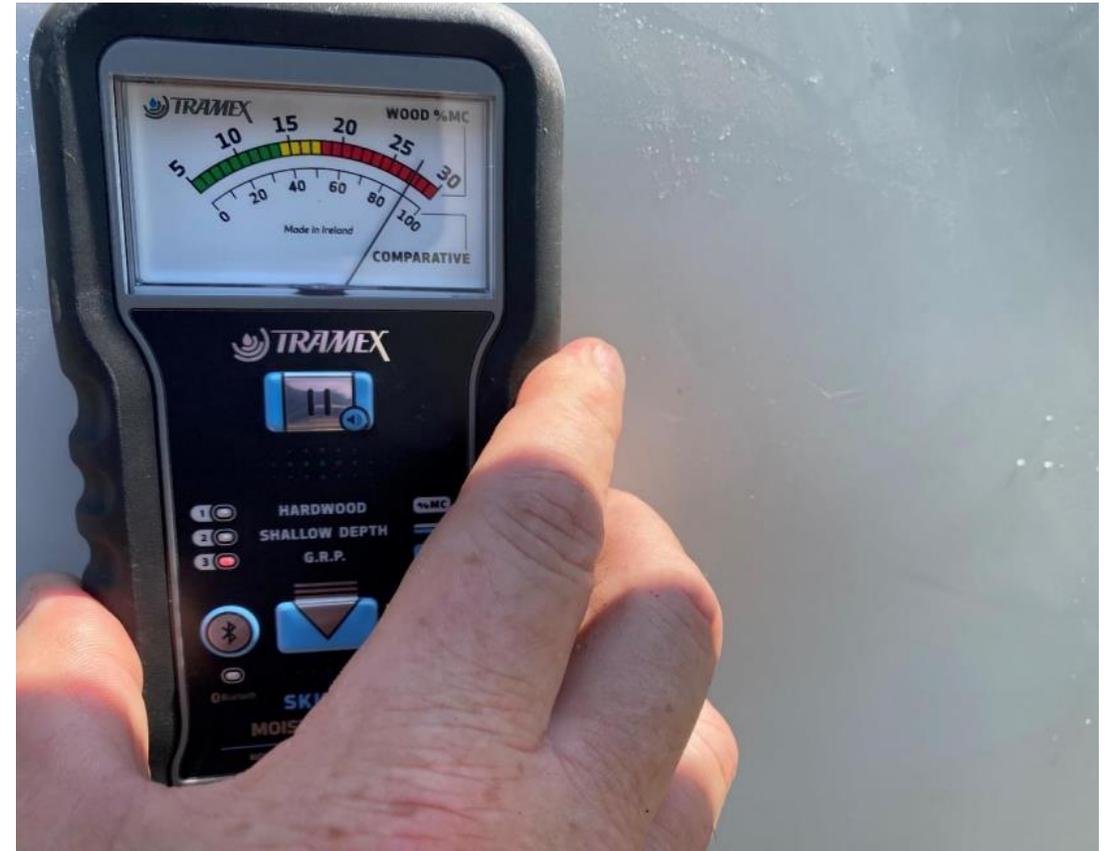
Heavy gel coat cracking in the superstructure with moderate moisture and delamination
