Year 5 Annual Report
Massachusetts Small MS4 General Permit
Reporting Period: July 1, 2022-June 30, 2023

Below are the observations made for 114 storm drain systems. Each drain system is referenced by the facility ID of the outfall pipe.

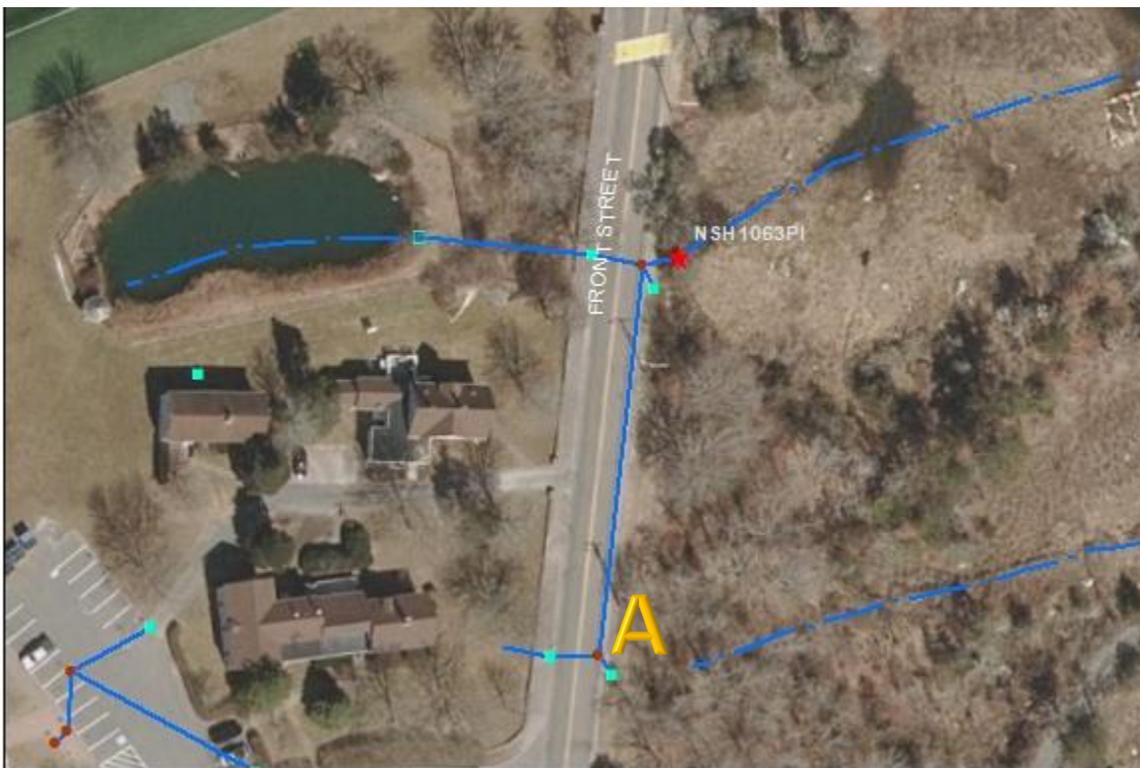
NSH1063PI- Front Street: No significant issues found. The manhole at point A was packed with dirt and had significant root growth. The Town cleaned it out and the connection between manholes was confirmed. It has previously flooded in this area. Further maintenance within the pipes may still be needed to avoid this.

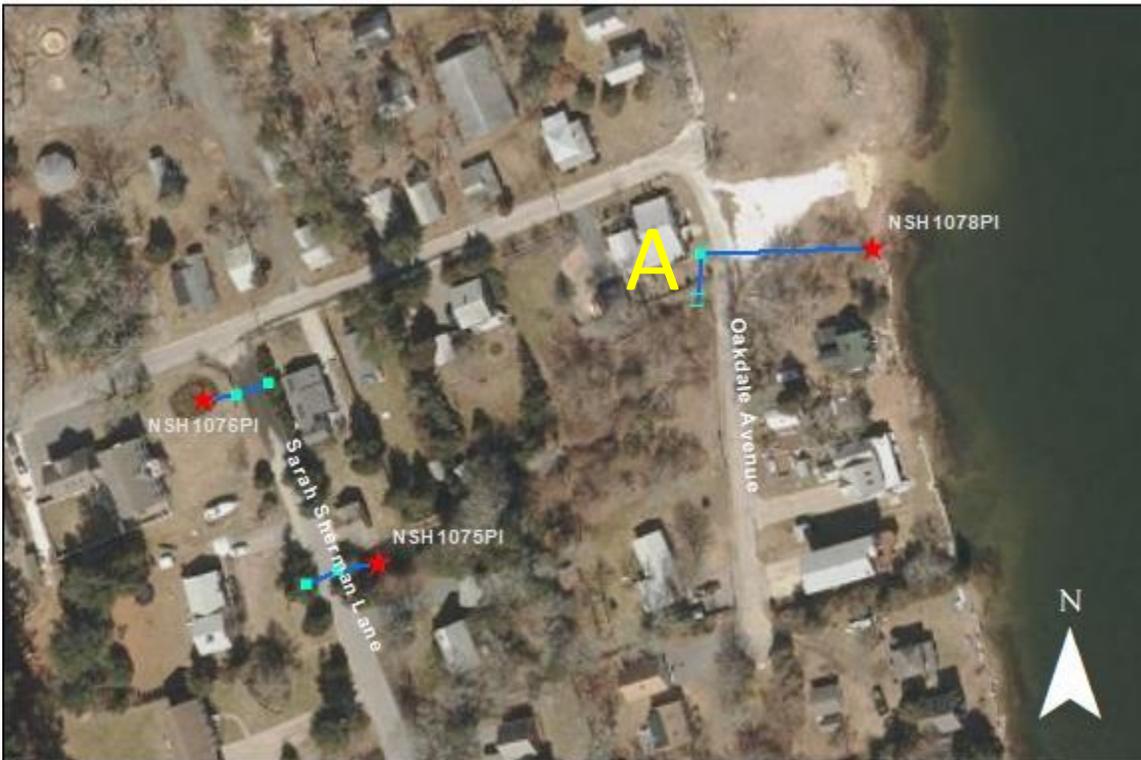
NSH1076PI and NSH1075PI- Sarah Sherman Lane: No issues found.
NSH1078PI- Oakdale Avenue: Pipe may be collapsed or buried. Unable to locate outfall. At point A, a clay pipe enters the catchbasin. Evidence pipe is broken in yard just South of basin.

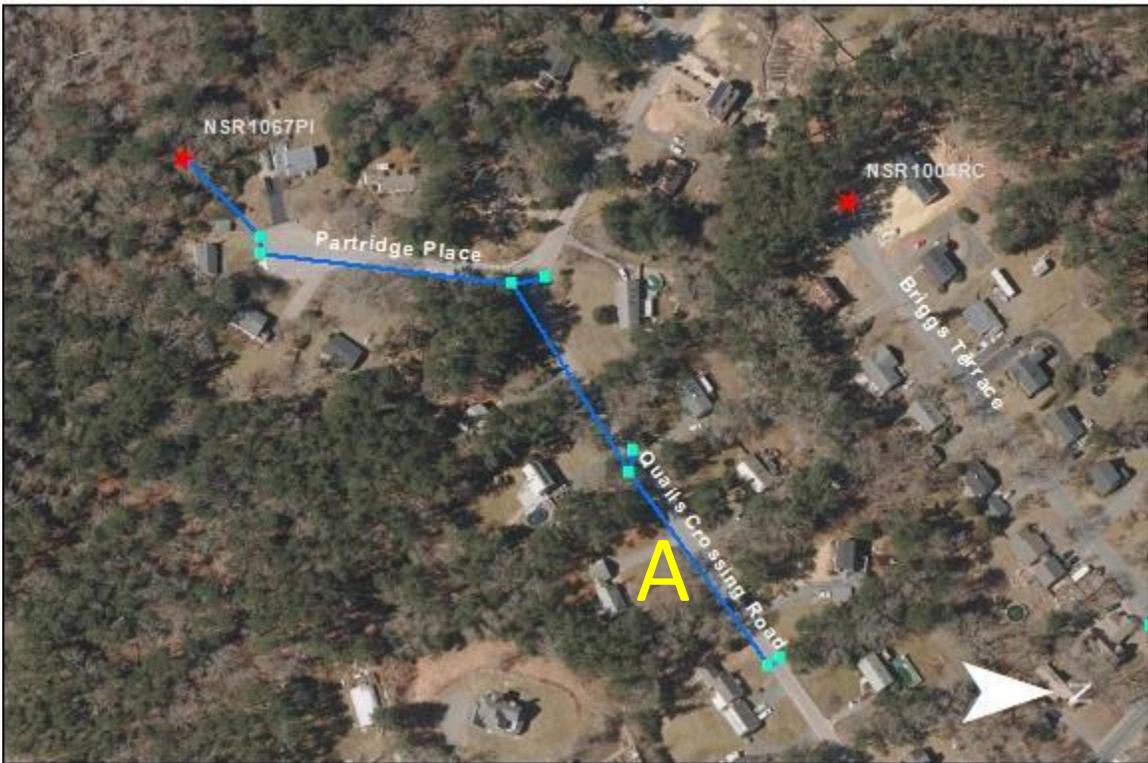
NSR1067PI- Partridge Place: No issues found. At point A groundwater is penetrating catchment at pipe seam.

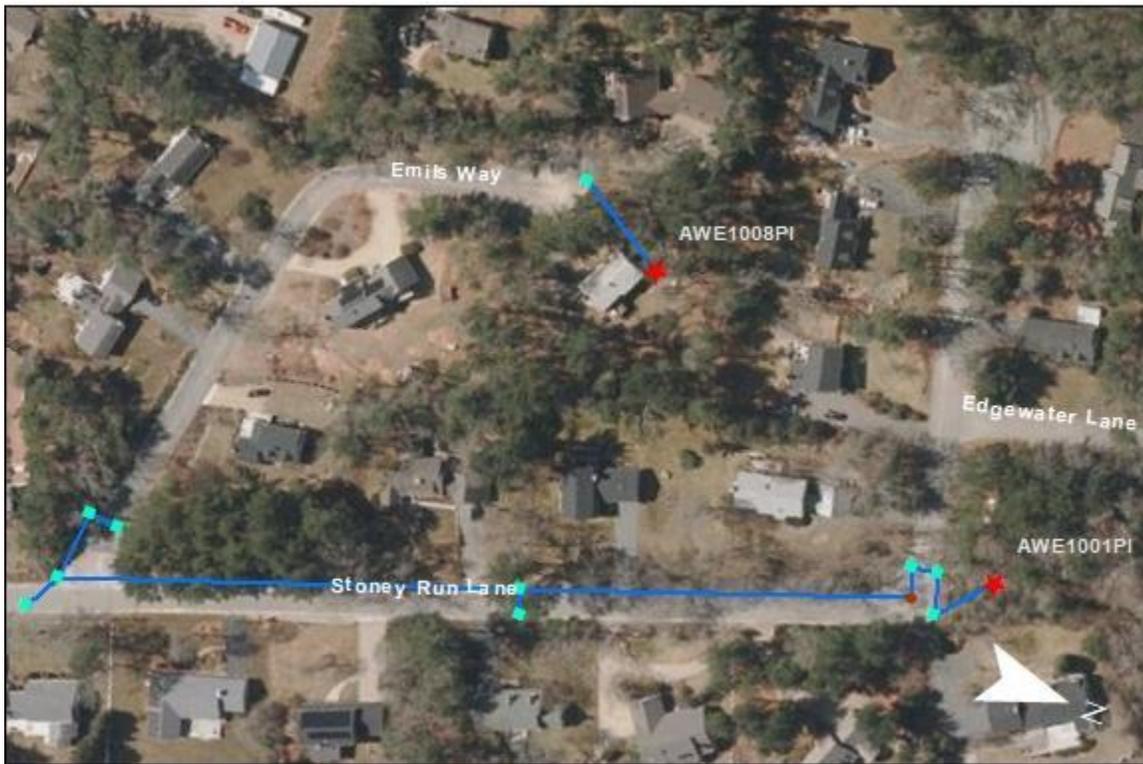
AWE1001PI- Stoney Run Lane: Structures near outfall are completely full of sand. Difficult to inspect due to debris. Further maintenance is suggested.

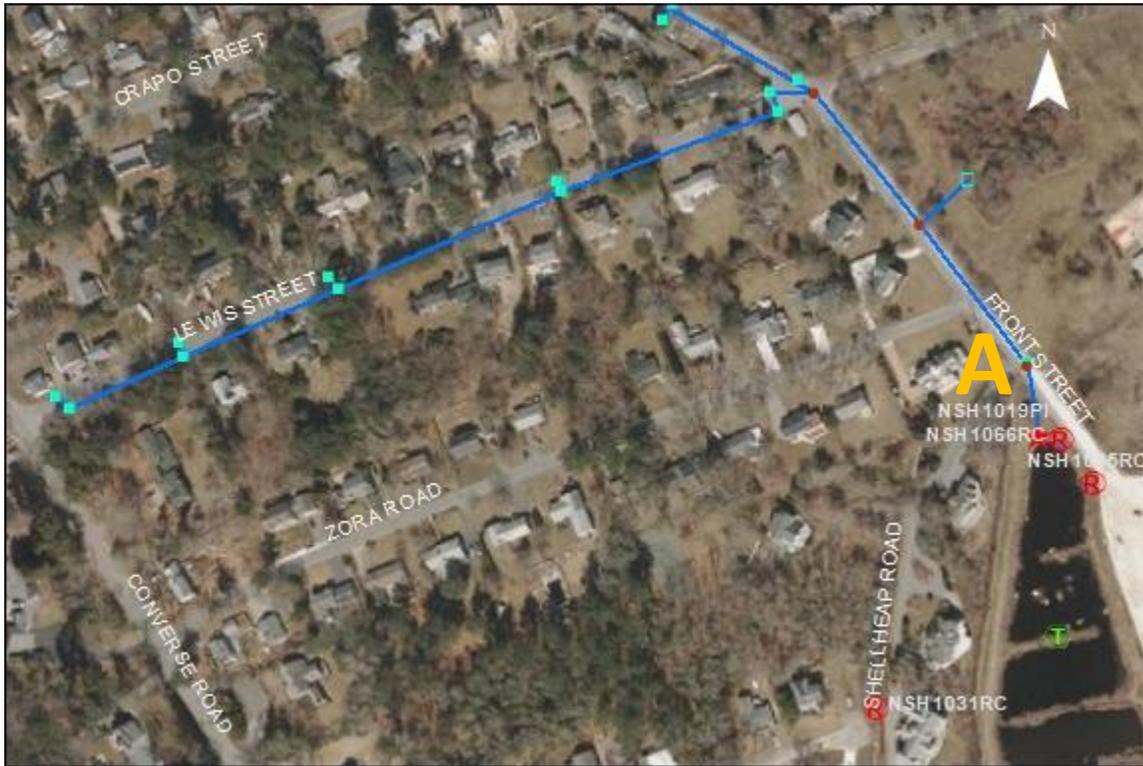
NSH1019PI (2/3)- Front Street: At point A and B the catchbasins have begun to sink. Both are in need of repair. Preventative maintenance is recommended.

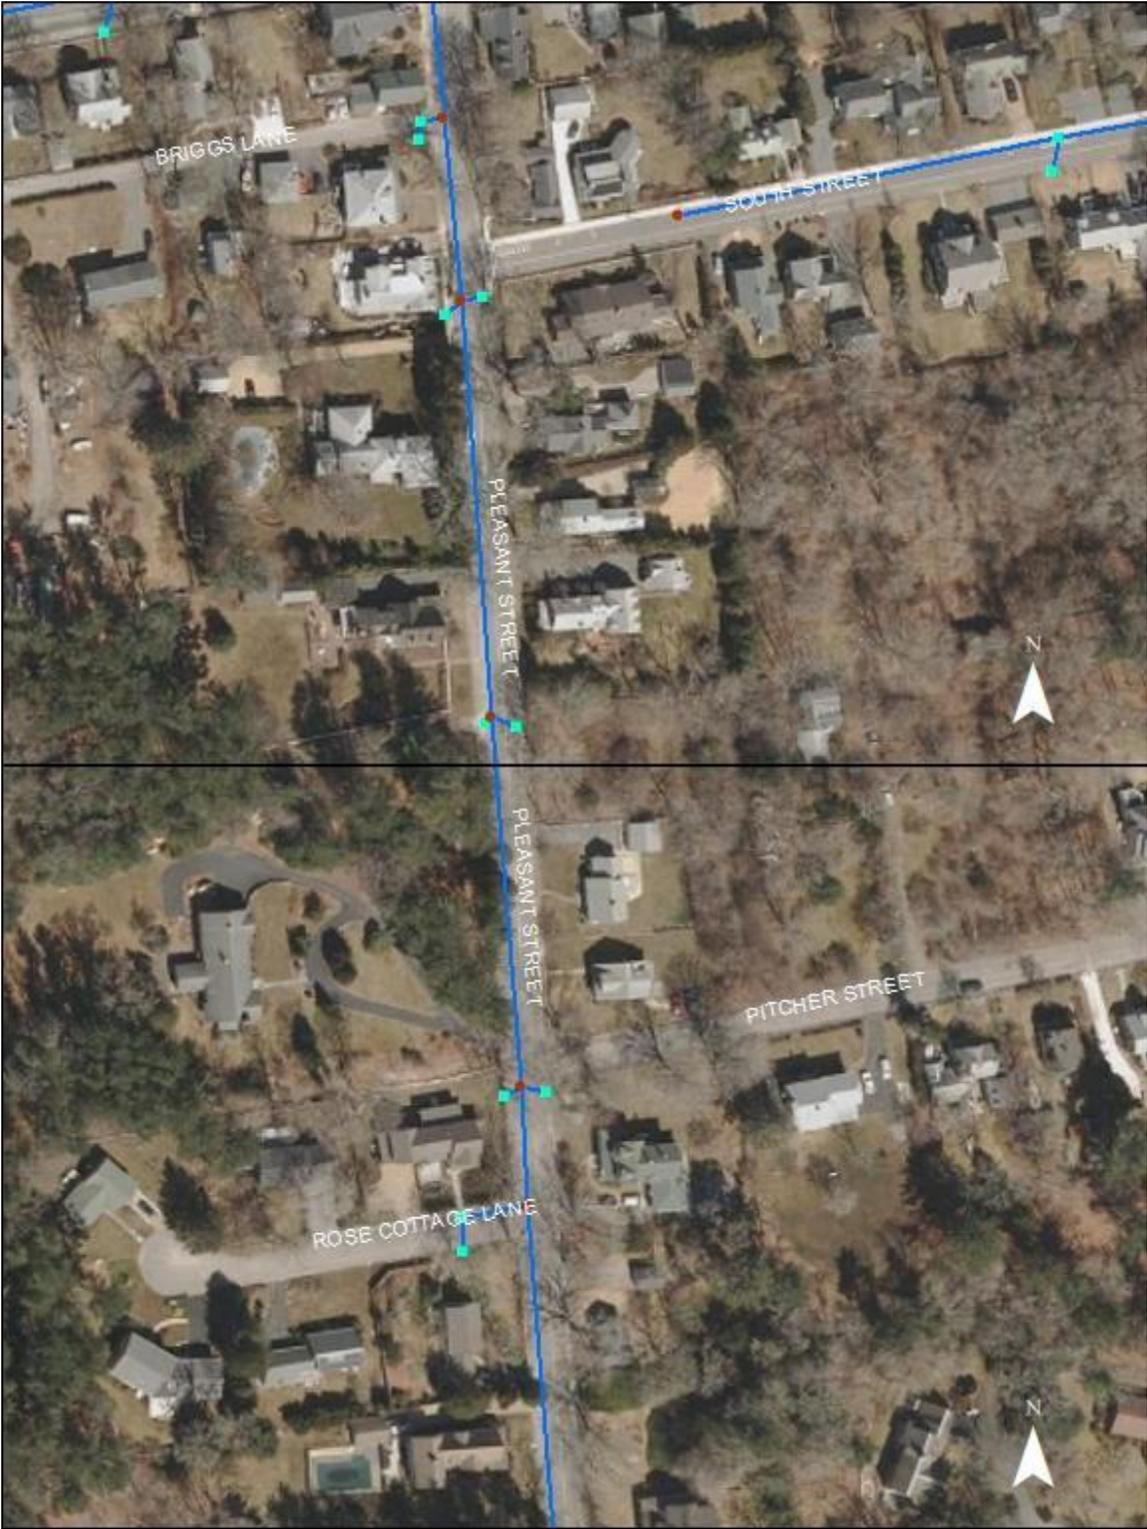
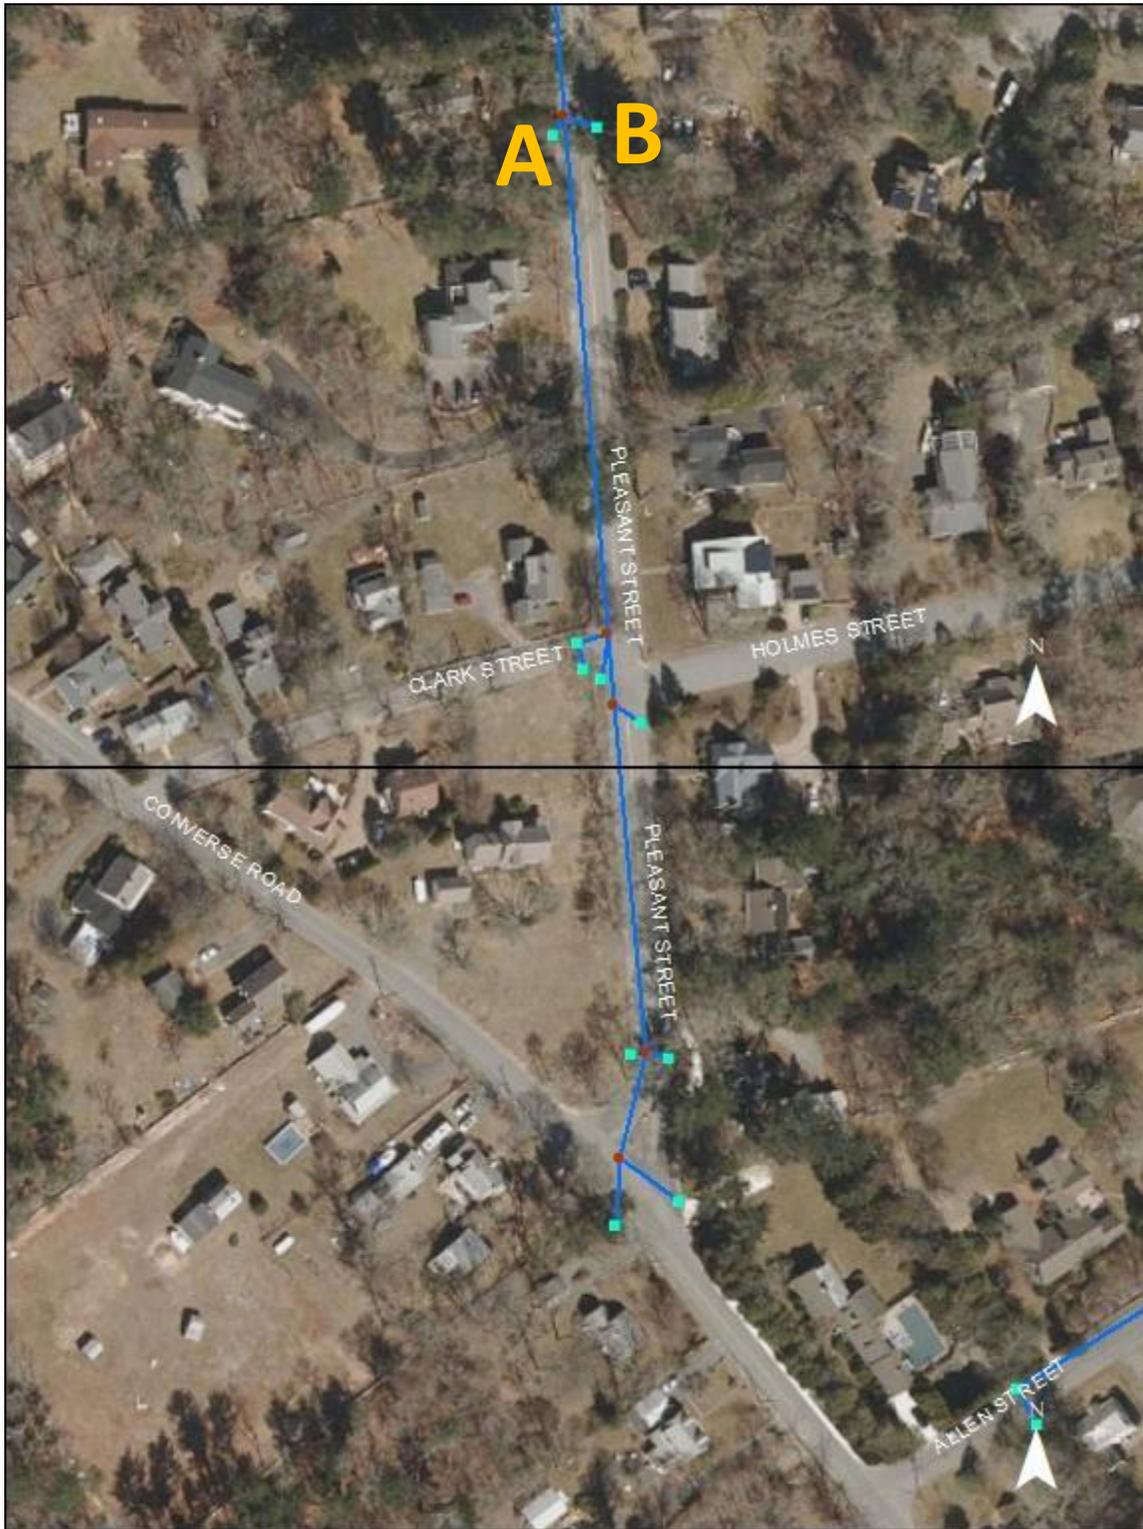
NSH1046PI (2/2) - Pleasant Street: At point A the bricks on the inside of the catchbasin are beginning to crumble. Catchbasin is in need of repair. At point B the catchbasin is full of dirt and not draining properly. The structure is in need of cleaning.

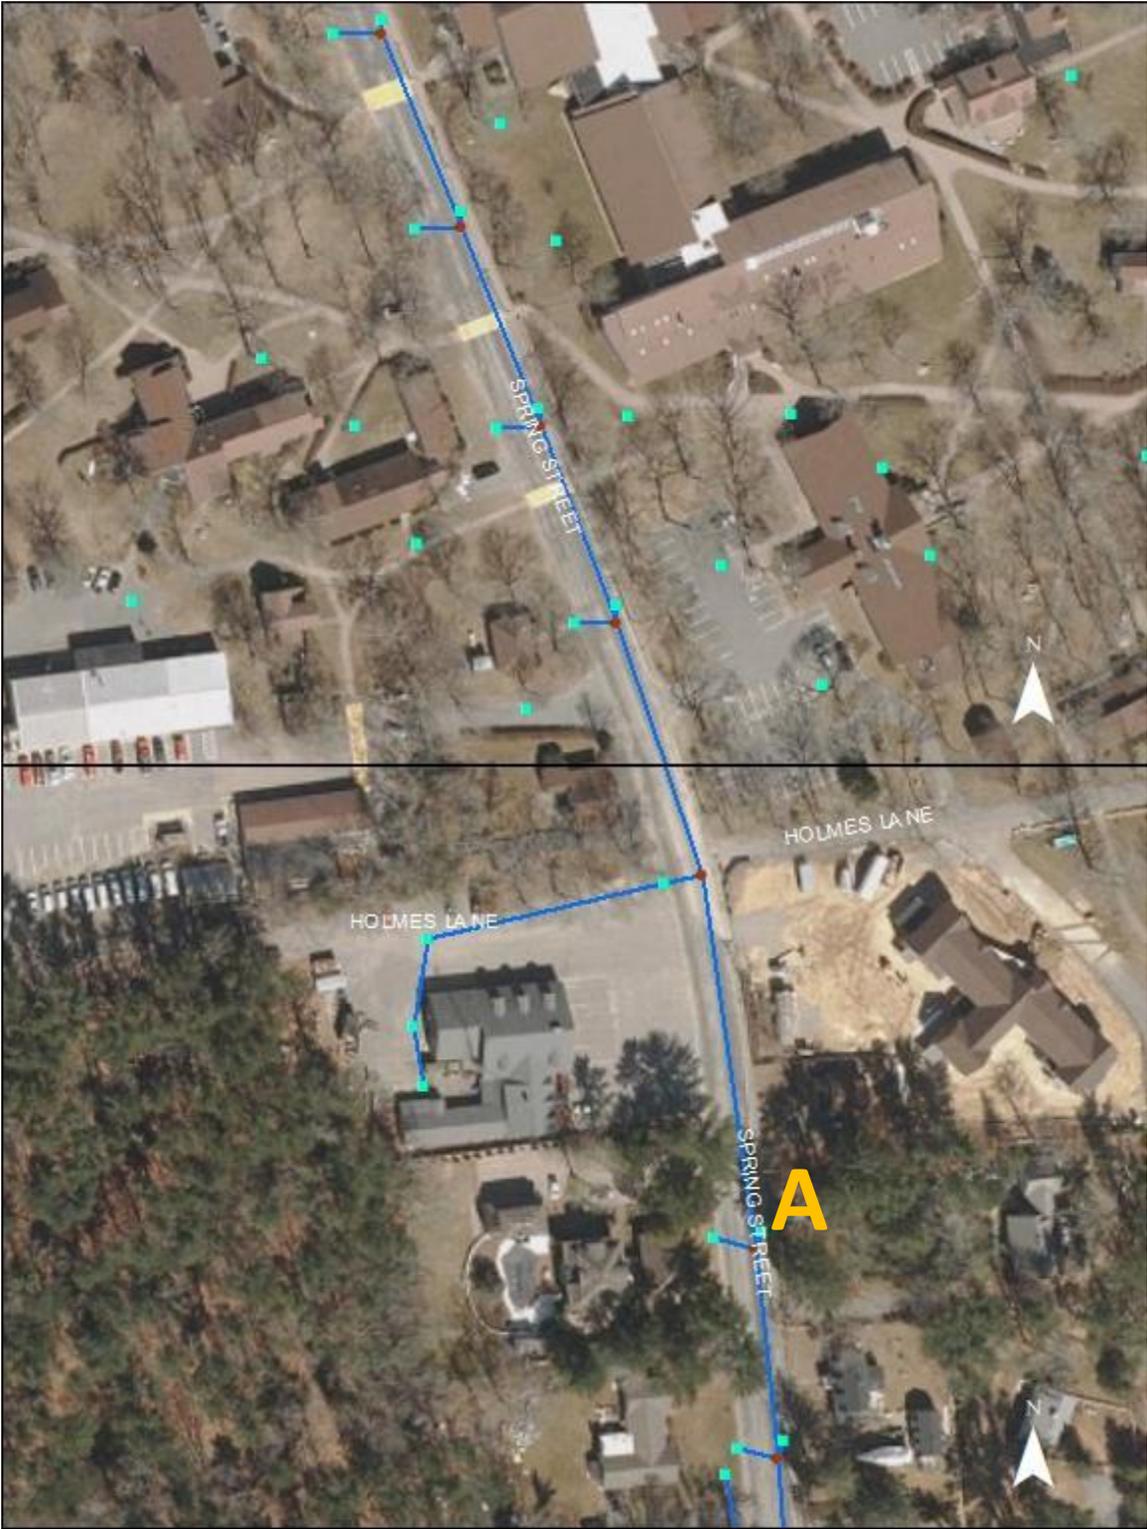
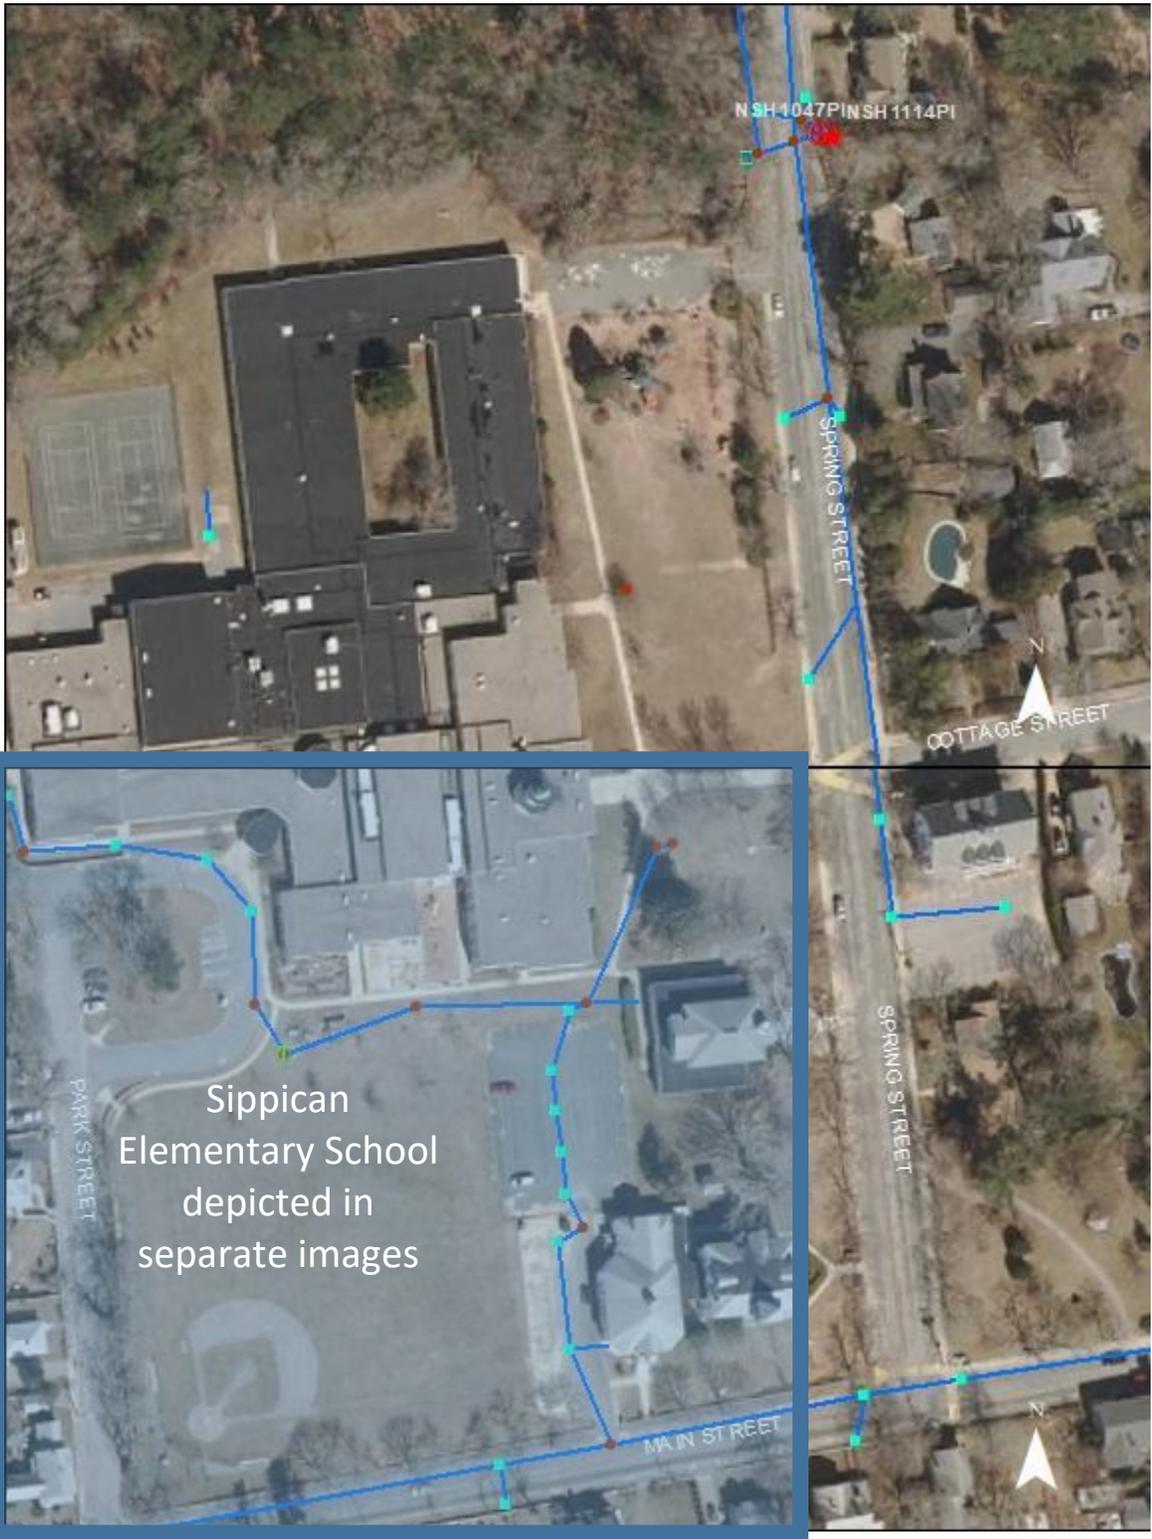
NSH1114PI and NSH1047PI- School Street: At point A there is a large construction sandbag inside the catchbasin. Its removal is recommended.

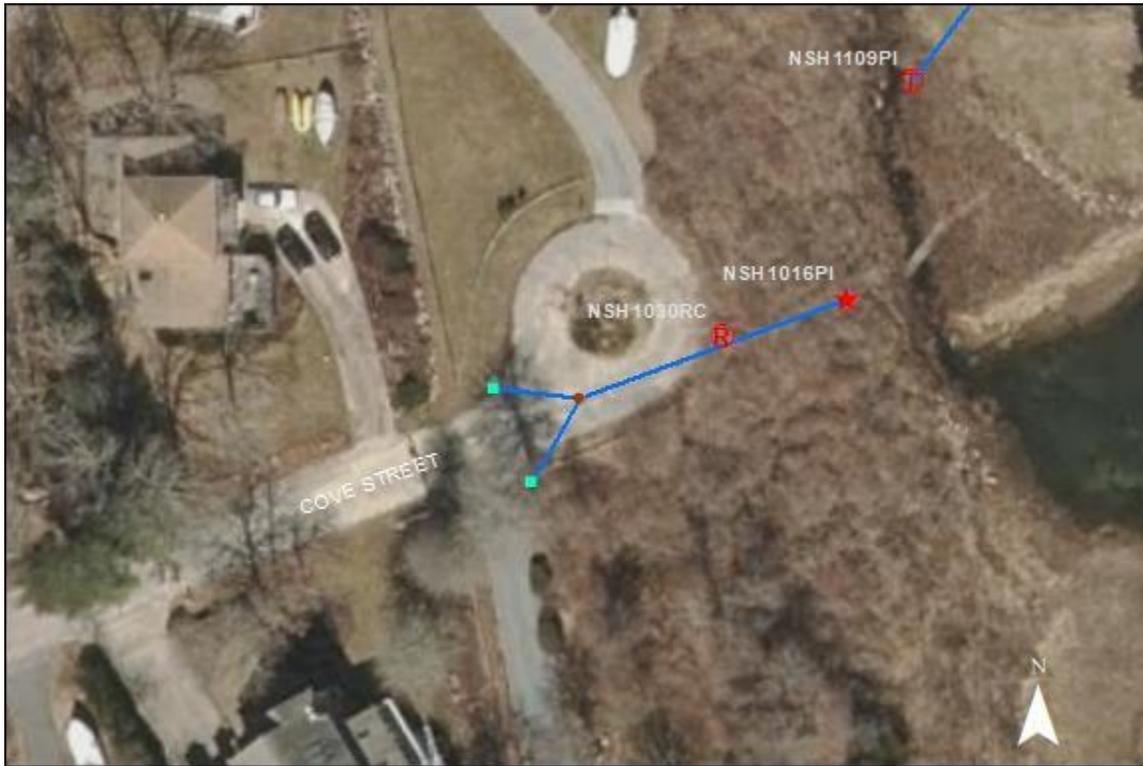
NSH1030RC and NSH1016PI- Cove Street: Catchbasins and the manhole on Cove Street are full of sand. Further maintenance is recommended.

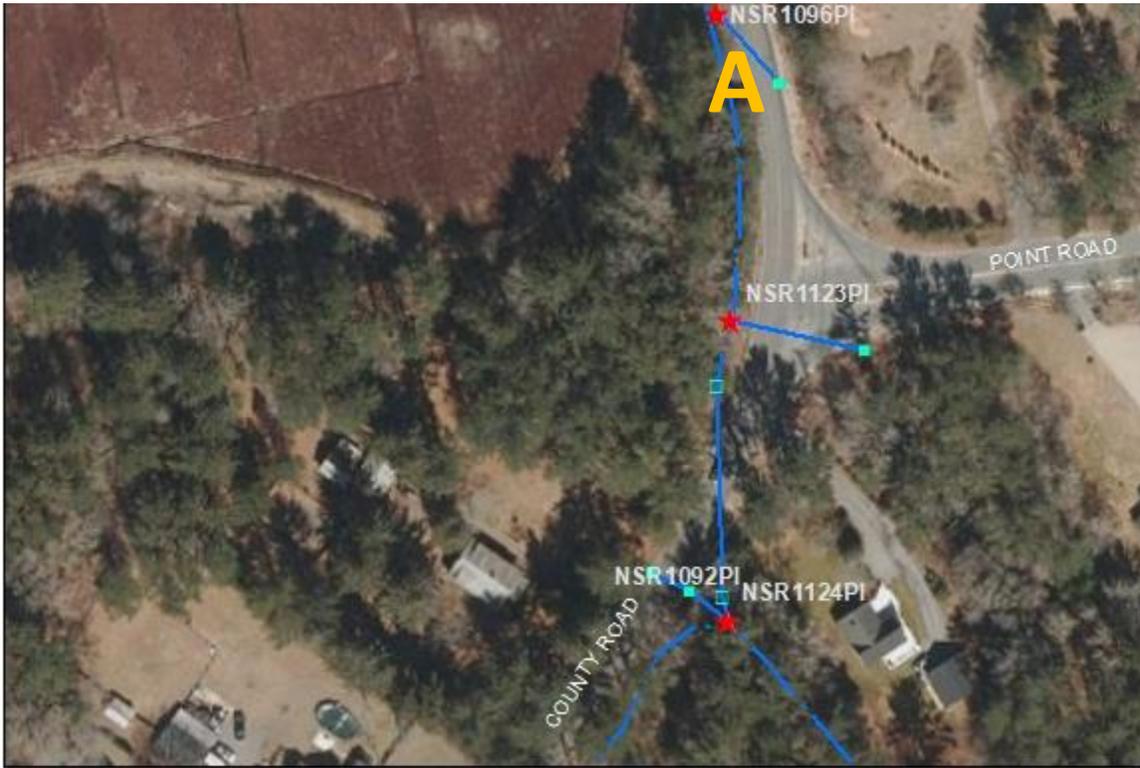
NSR1096PI, NSR1123PI, NSR1092PI, and NSR1124PI- County Road at Point Road: No significant issues. Pipe at point A is clogged. Further maintenance is recommended.

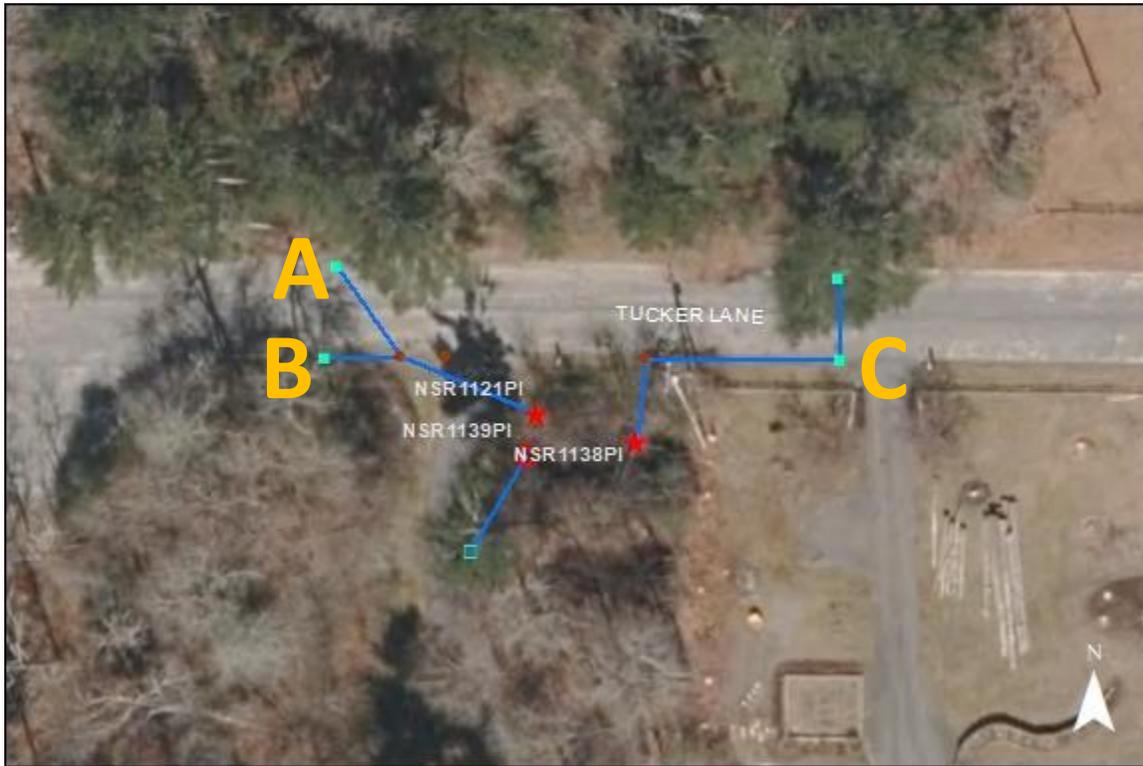
NSR1121PI, NSR1139PI, and NSR1138PI- Tucker Lane: Catchbasins at A, B, and C have all begun to sink. Preventative maintenance is recommended.

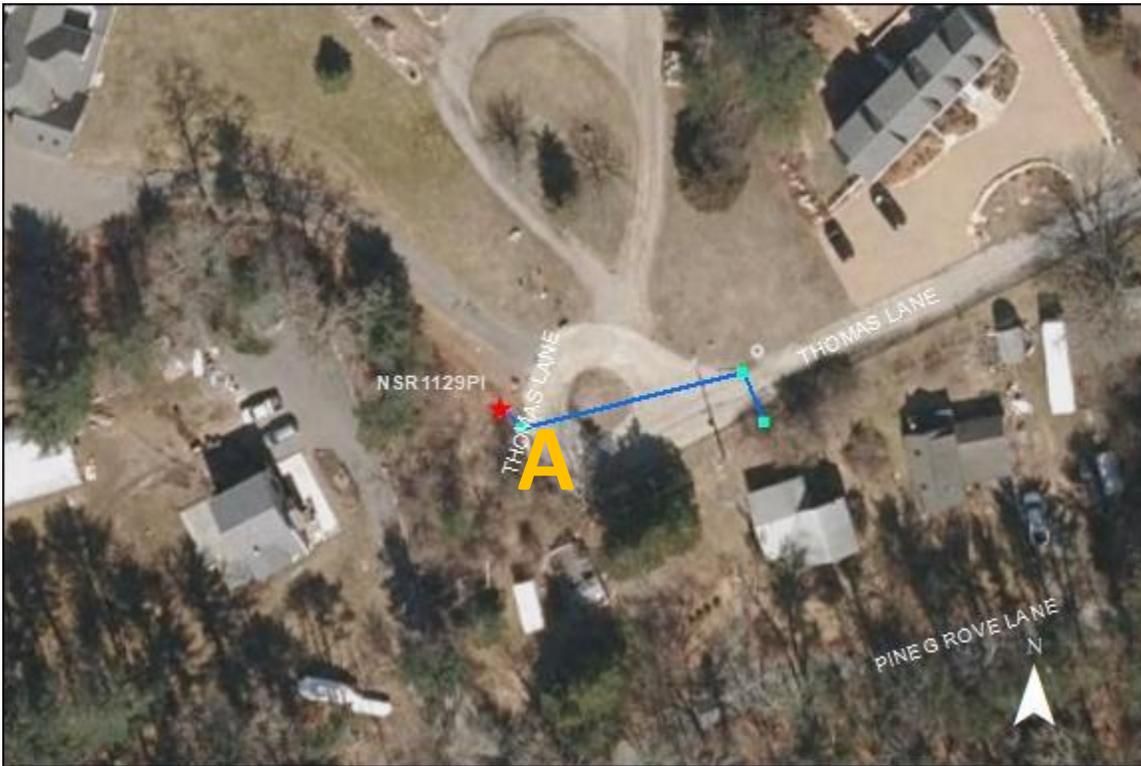
NSR1129PI- Thomas Lane: The catchbasin at point A had a lot of lumber dumped into it. Catchbasin should be cleared of debris.

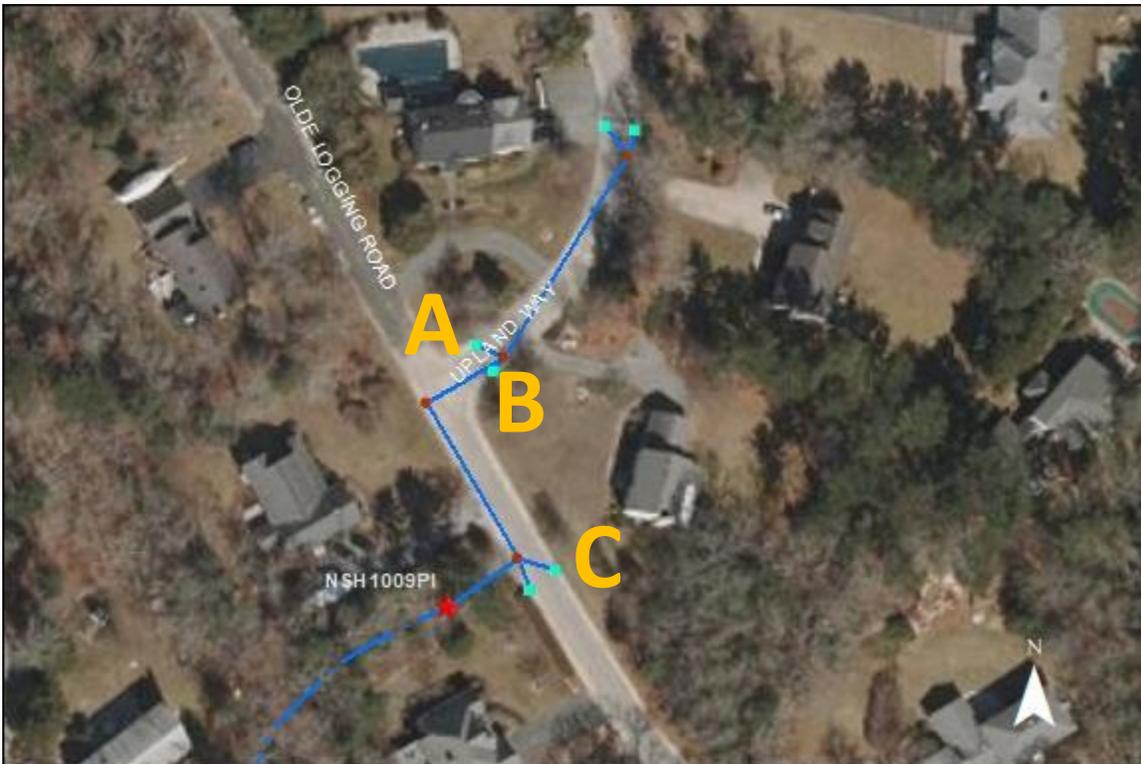
NSH1009PI- Upland Way and Olde Logging Road: At point A, B, and C, the catchbasins are beginning to sink and the frames are beginning to chip. Preventative maintenance is recommended.

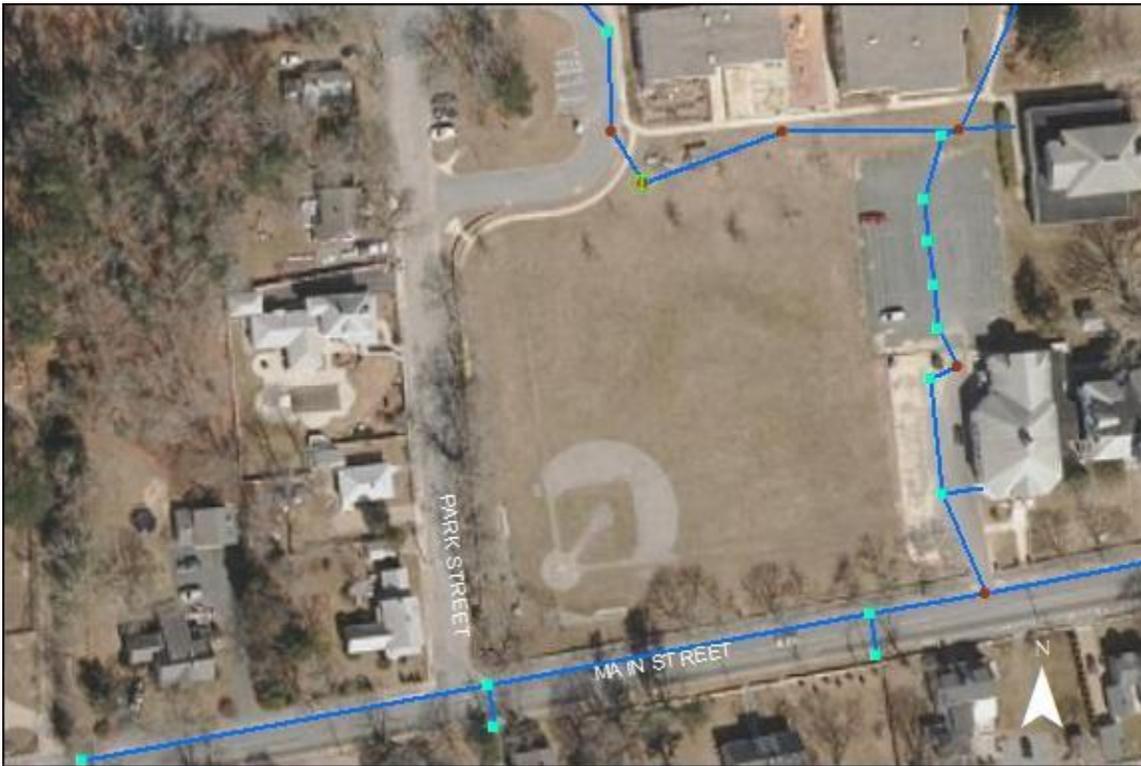
Sippican Elementary School- No issues observed. At point A there is a 12" cement pipe running through the structure. It is damaged. Unsure of what that piper carries. Further attention is strongly recommended.

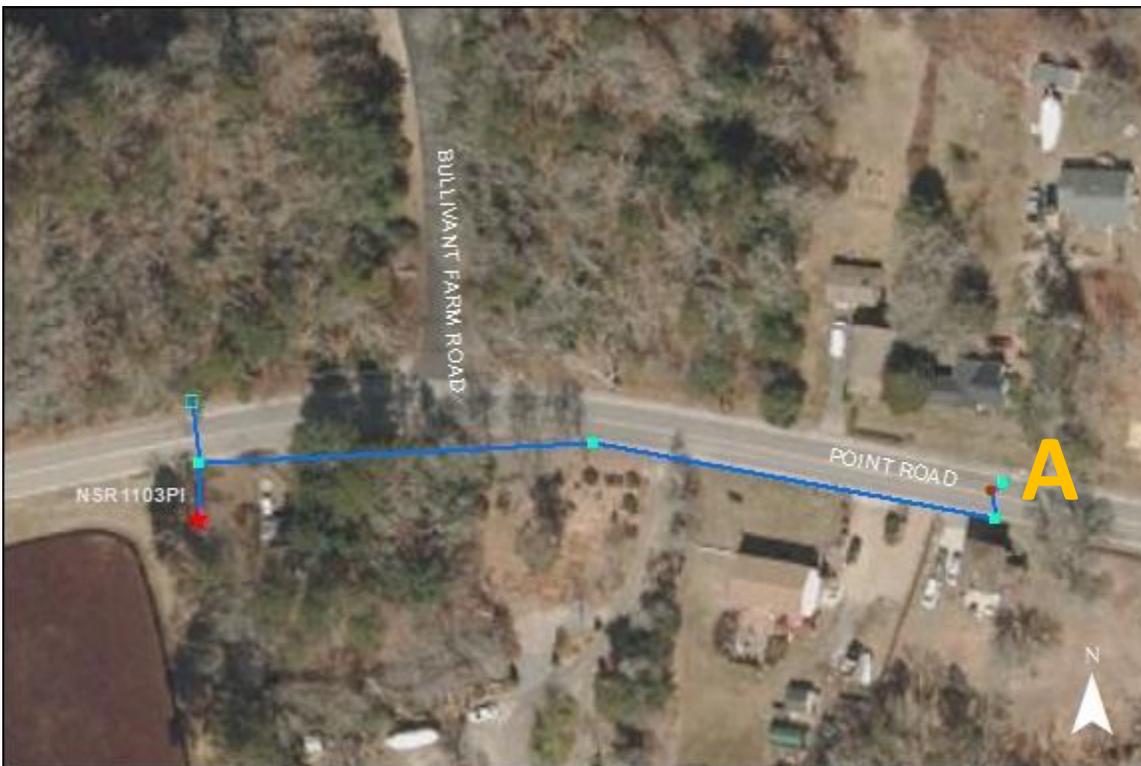
NSR1103PI- Point Road: At Point A, both the manhole and catchbasin are full of dirt. Further maintenance is recommended.

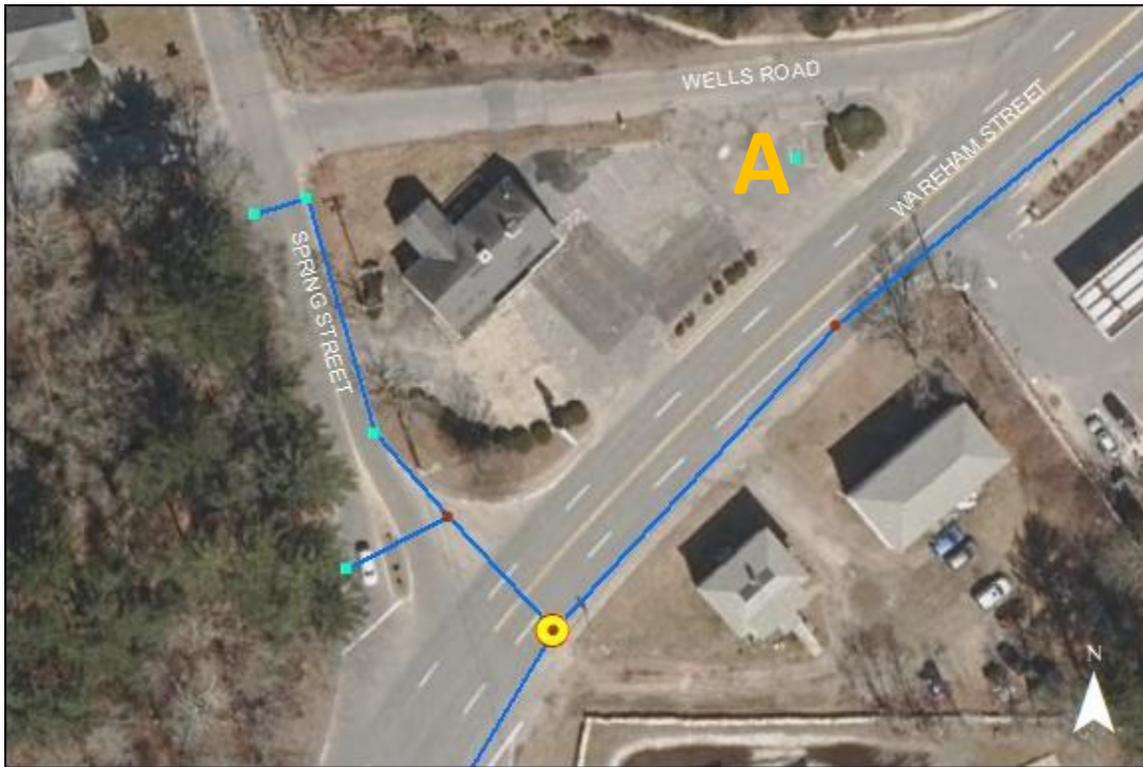
Spring Street: No issues found. Spring Street drains into a state road as shown at the yellow circle above. The catchbasin shown at point A is sinking. Further maintenance is suggested.

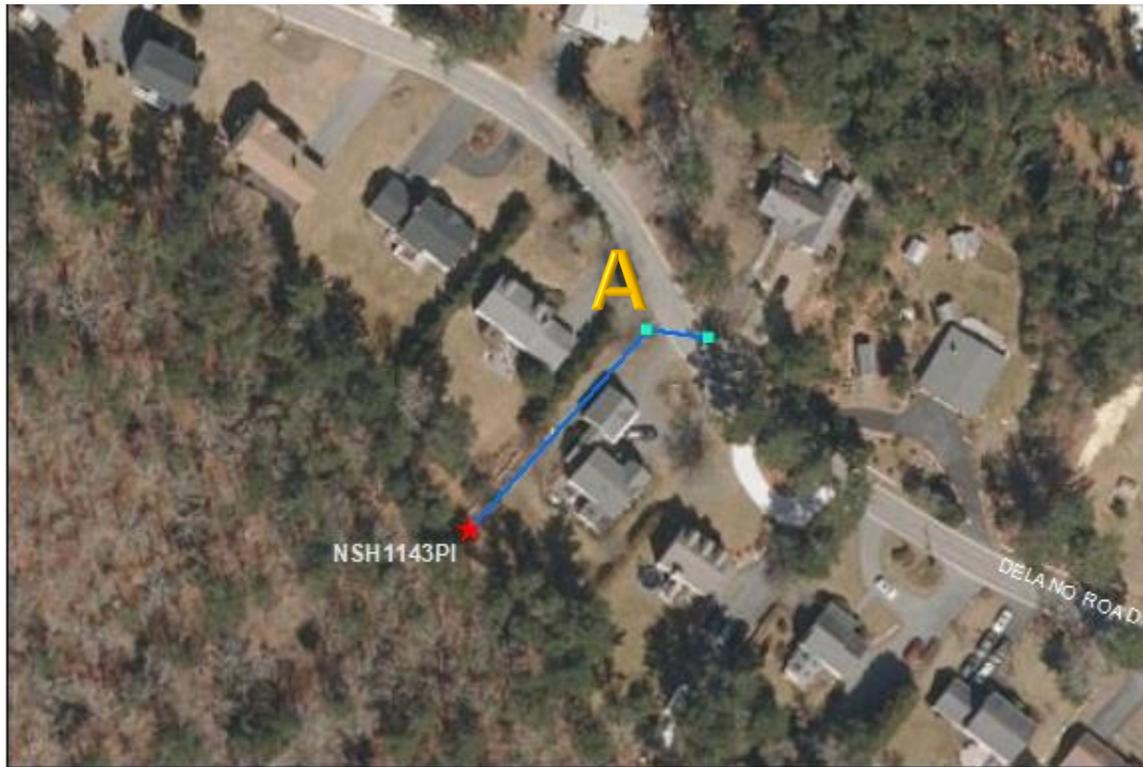
NSH1143PI- Delano Road: No significant issues found. At point A the road floods during rain events. There is a small 4" HDPE pipe located above ground to help relieve this issue. However, it does not extend far enough to drain the water retention in front of house #529. Further remediation is recommended.
