Year 5 Annual Report
Massachusetts Small MS4 General Permit
Reporting Period: July 1, 2022-June 30, 2023

Below are the observations made for 114 storm drain systems. Each drain system is referenced by the facility ID of the outfall pipe.

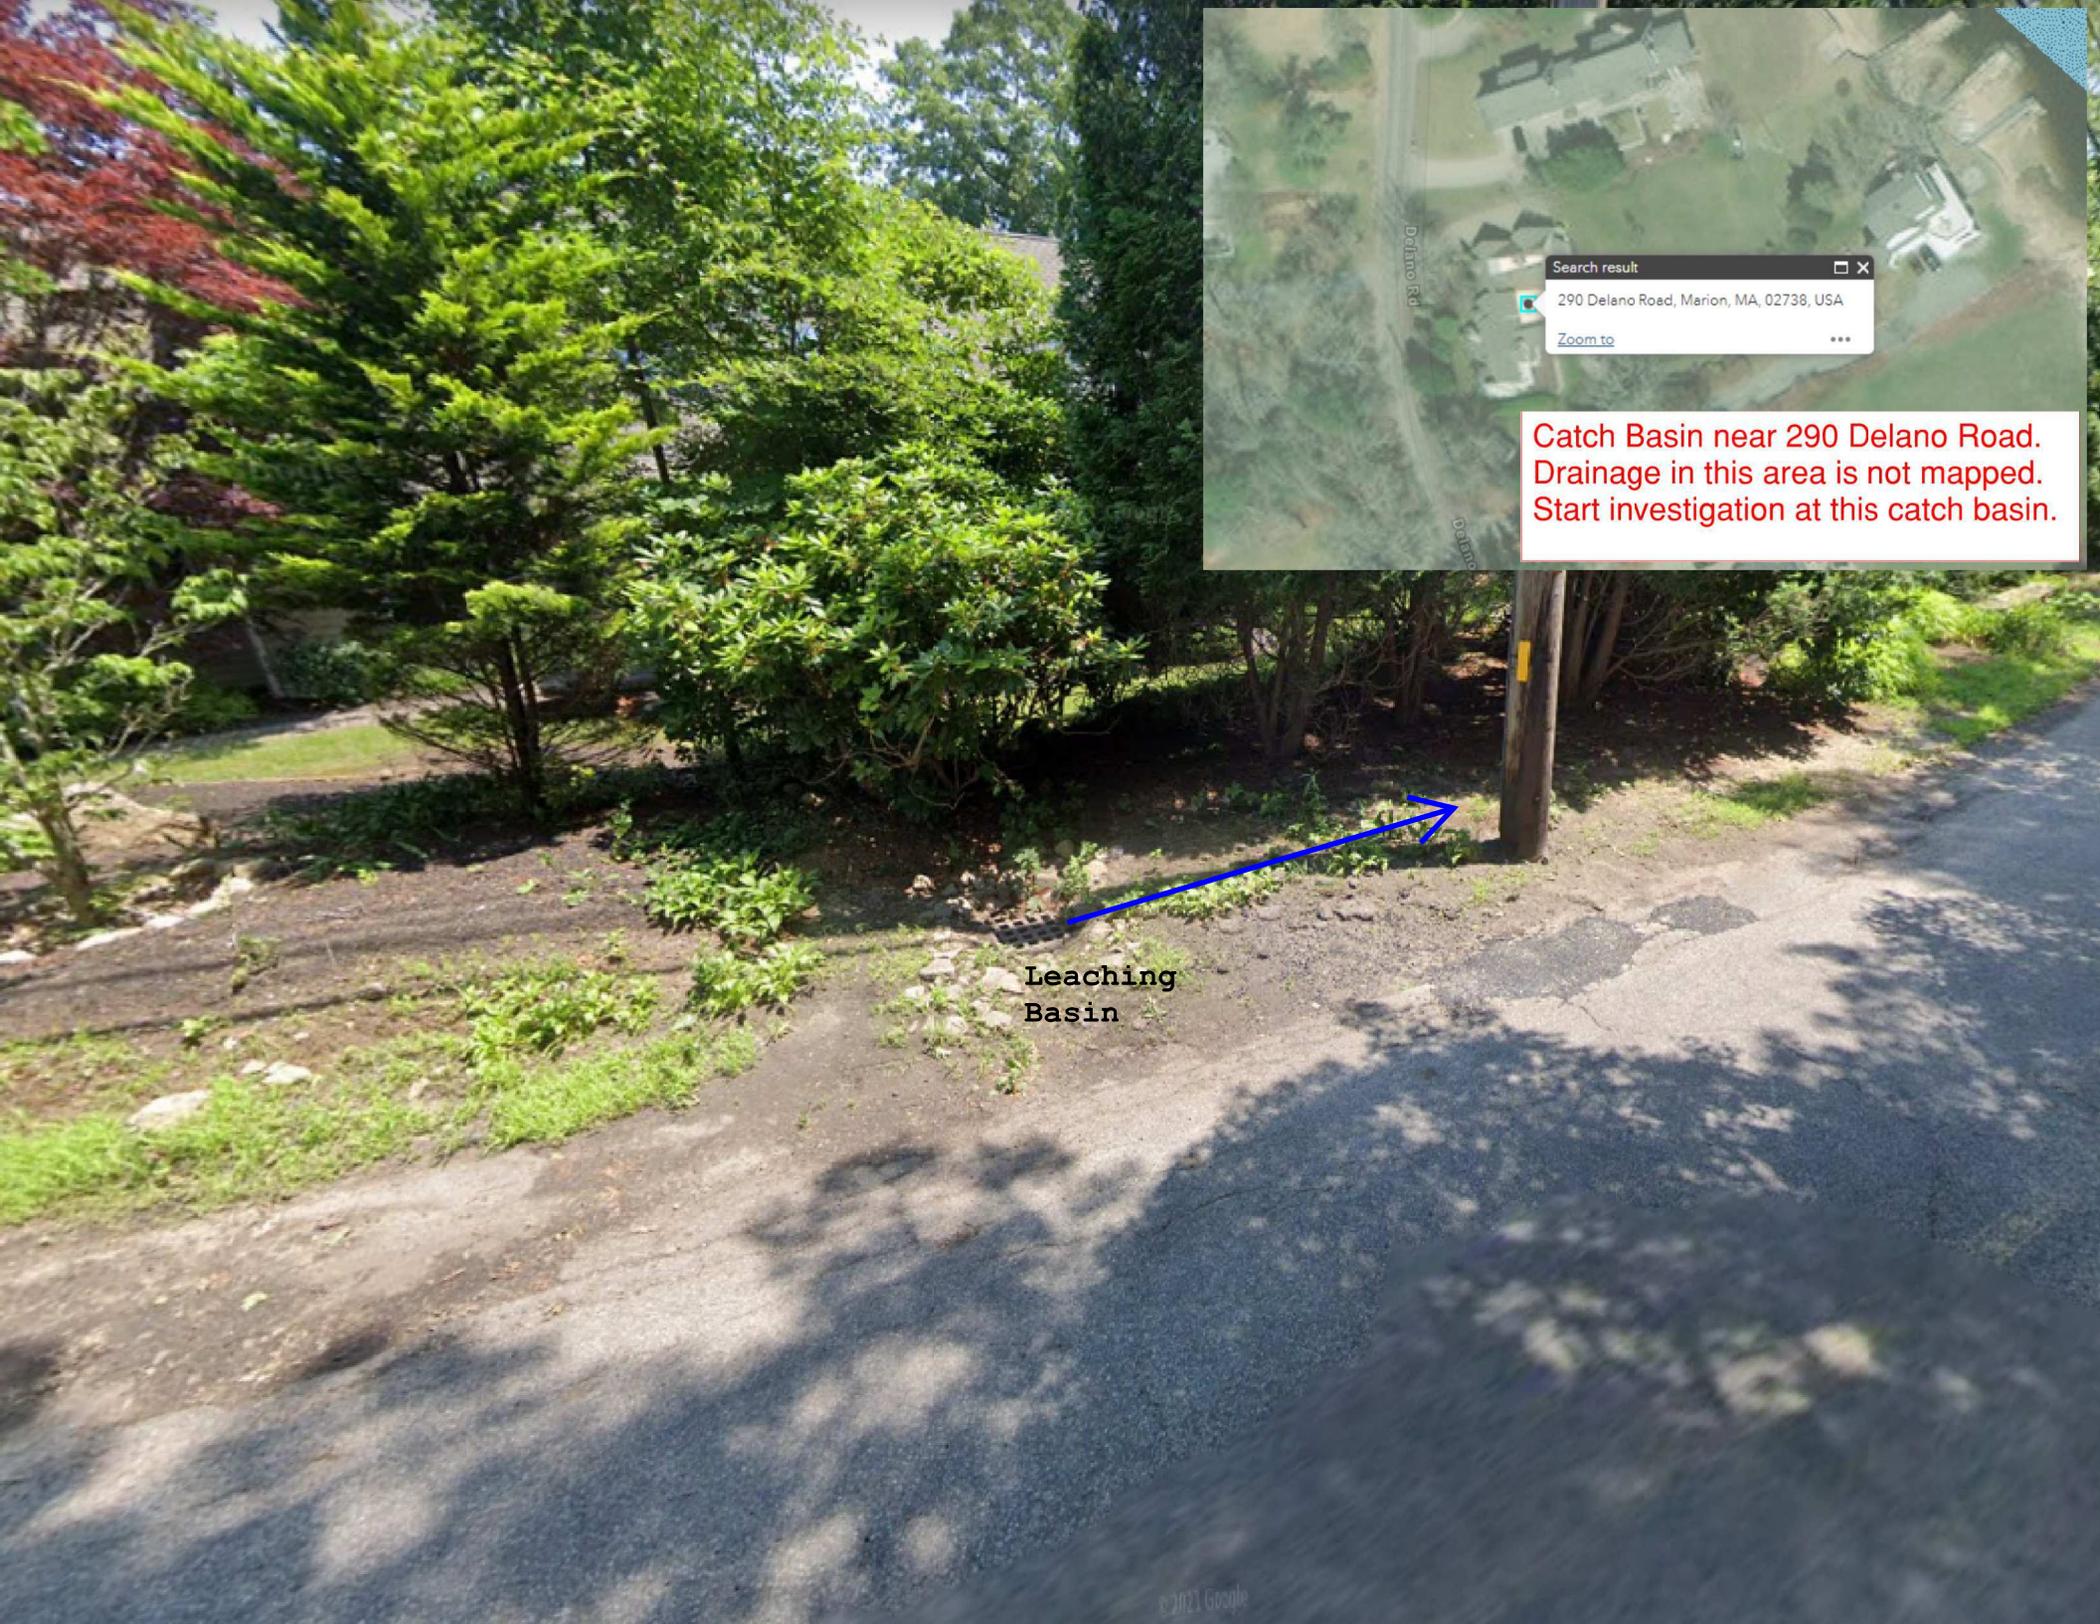
Catch Basin near 290 Delano Road.
Drainage in this area is not mapped.
Start investigation at this catch basin.

Televised approx. 90 LF upstream of this CB. Could not clean do to condition of pipe.

Recommend replacement of the 4-inch outgoing pipe with potentially a larger pipe and discharge to an infiltration basin, if possible. There is no town-owned drainage network within a practical distance to this location to connect to at this time.

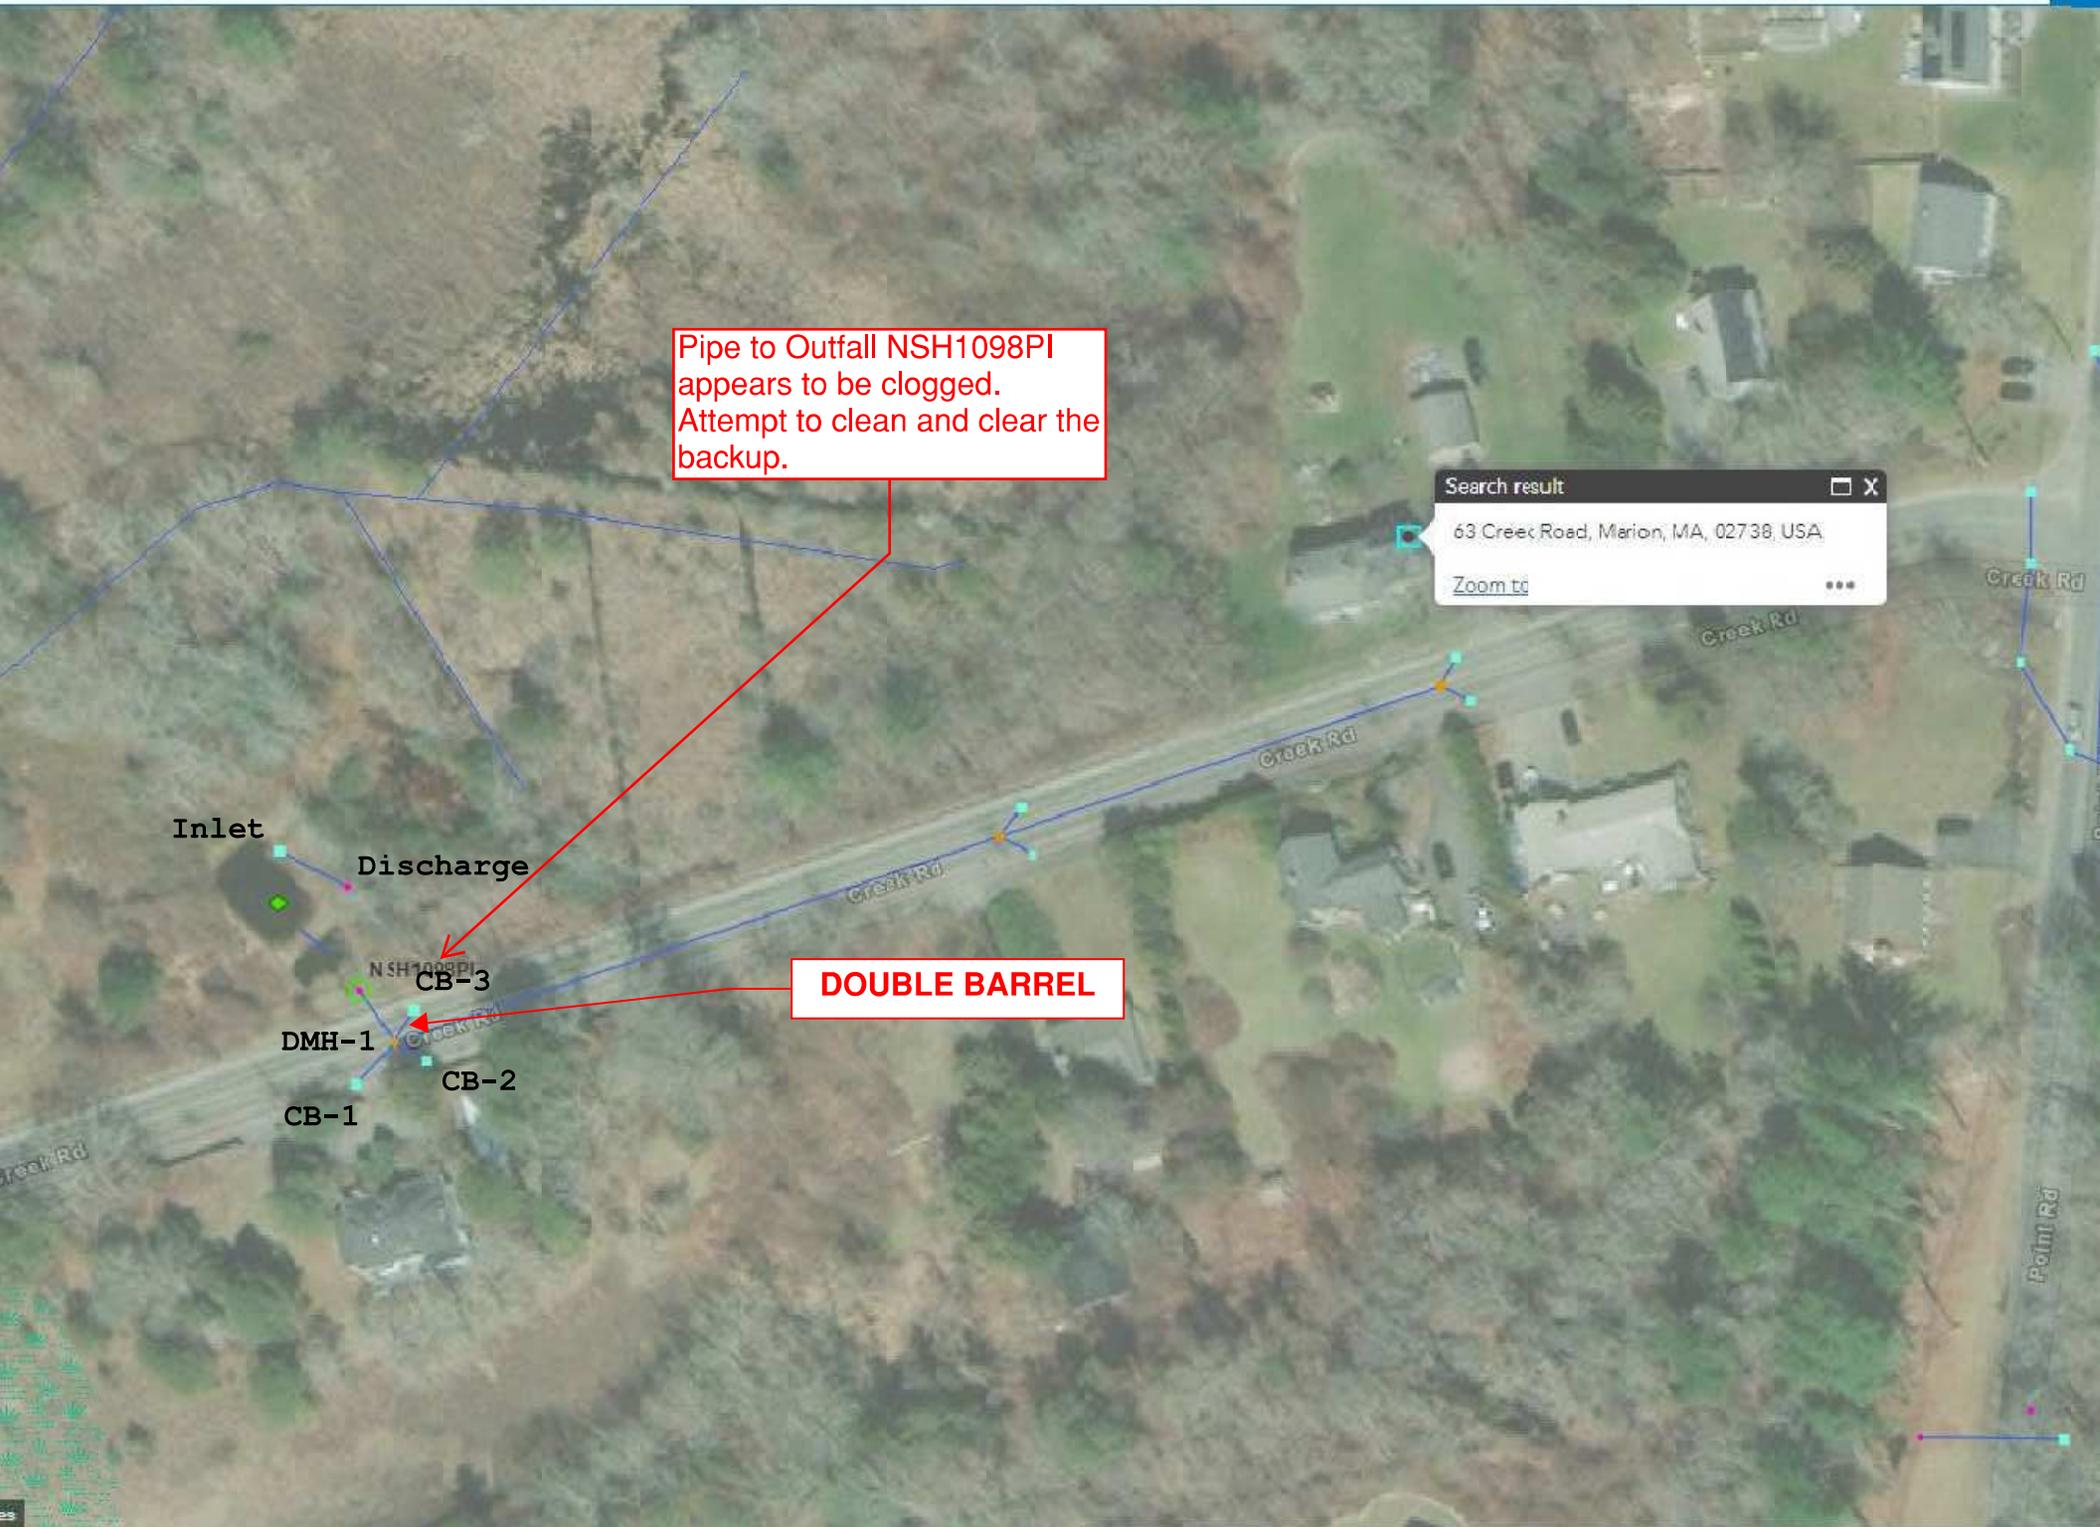
Pipe to Outfall NSH1098PI appears to be clogged. Attempt to clean and clear the backup.

Recommend clearing area around NSH1098PI as it appears debris buildup could impede flow from the catch basins on Creek Rd. In addition, recommend replacement of drain from Discharge to Inlet due to collapse identified during the investigation.
