Year 4 Annual Report
Massachusetts Small MS4 General Permit
Reporting Period: July 1, 2021-June 30, 2022

Town of Marion Report

August 2022

The area inspected was the drain networks located in the watershed on the West side of Sippican Harbor. Below are the observations made for each of the 99 storm drain systems. Each drain system is referenced by the facility ID of the outfall pipe.

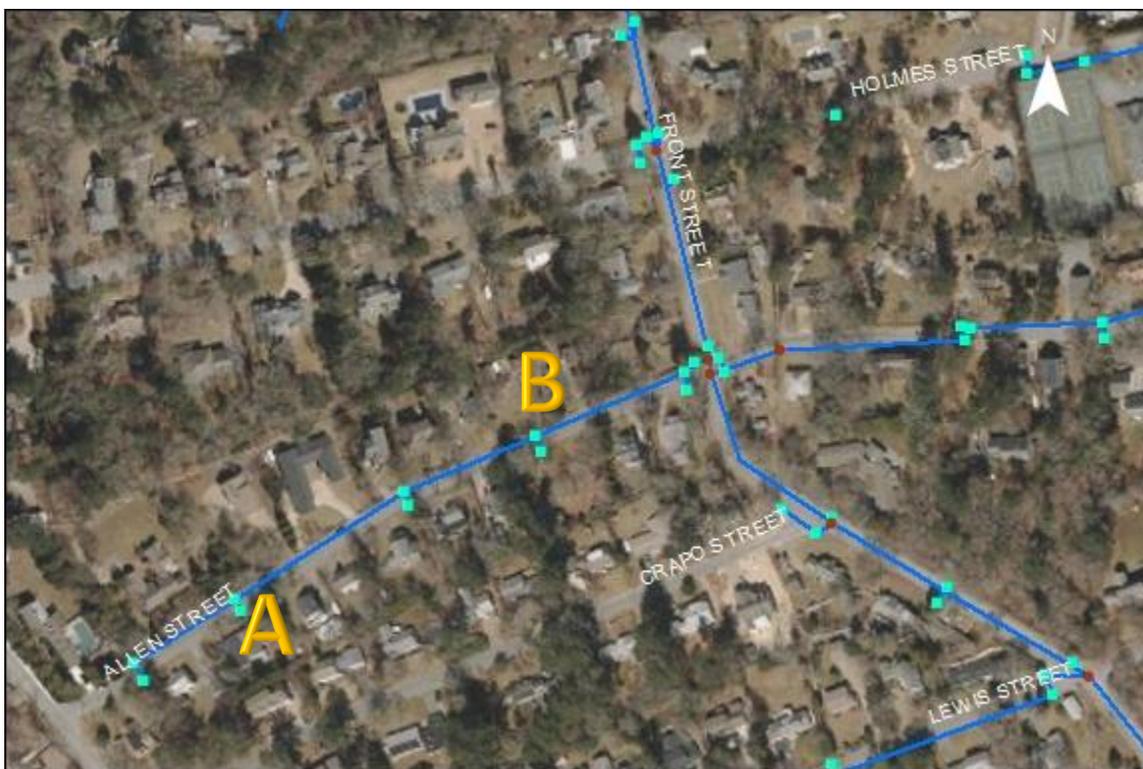
NSH1019PI (1/3)- Front Street and Lewis Street: No significant issues found. Two 12-inch concrete pipes enter the manhole at point A. Their origins are unknown. Further investigation is suggested. Also, several basins on Lewis Street had large amount of sand and leaf debris. Further maintenance is suggested.

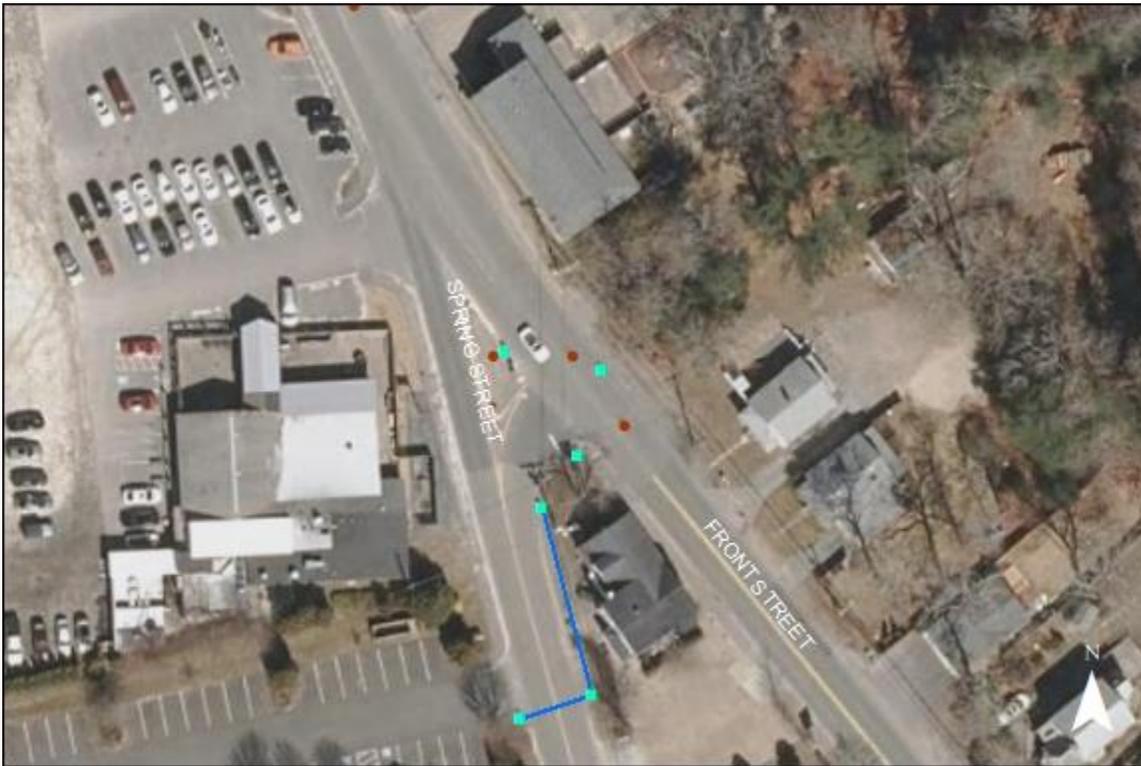
Spring Street: No issues found. Spring Street drains into a state road as shown at the yellow circle above. The catchbasin shown at point A is sinking. Further maintenance is suggested.
