2006 27ft Boston Whaler Challenger
Powered by twin 2016 Yamaha 300 Outboards

Vessel MH-1 Purchased in 2006

Current condition of MH-1

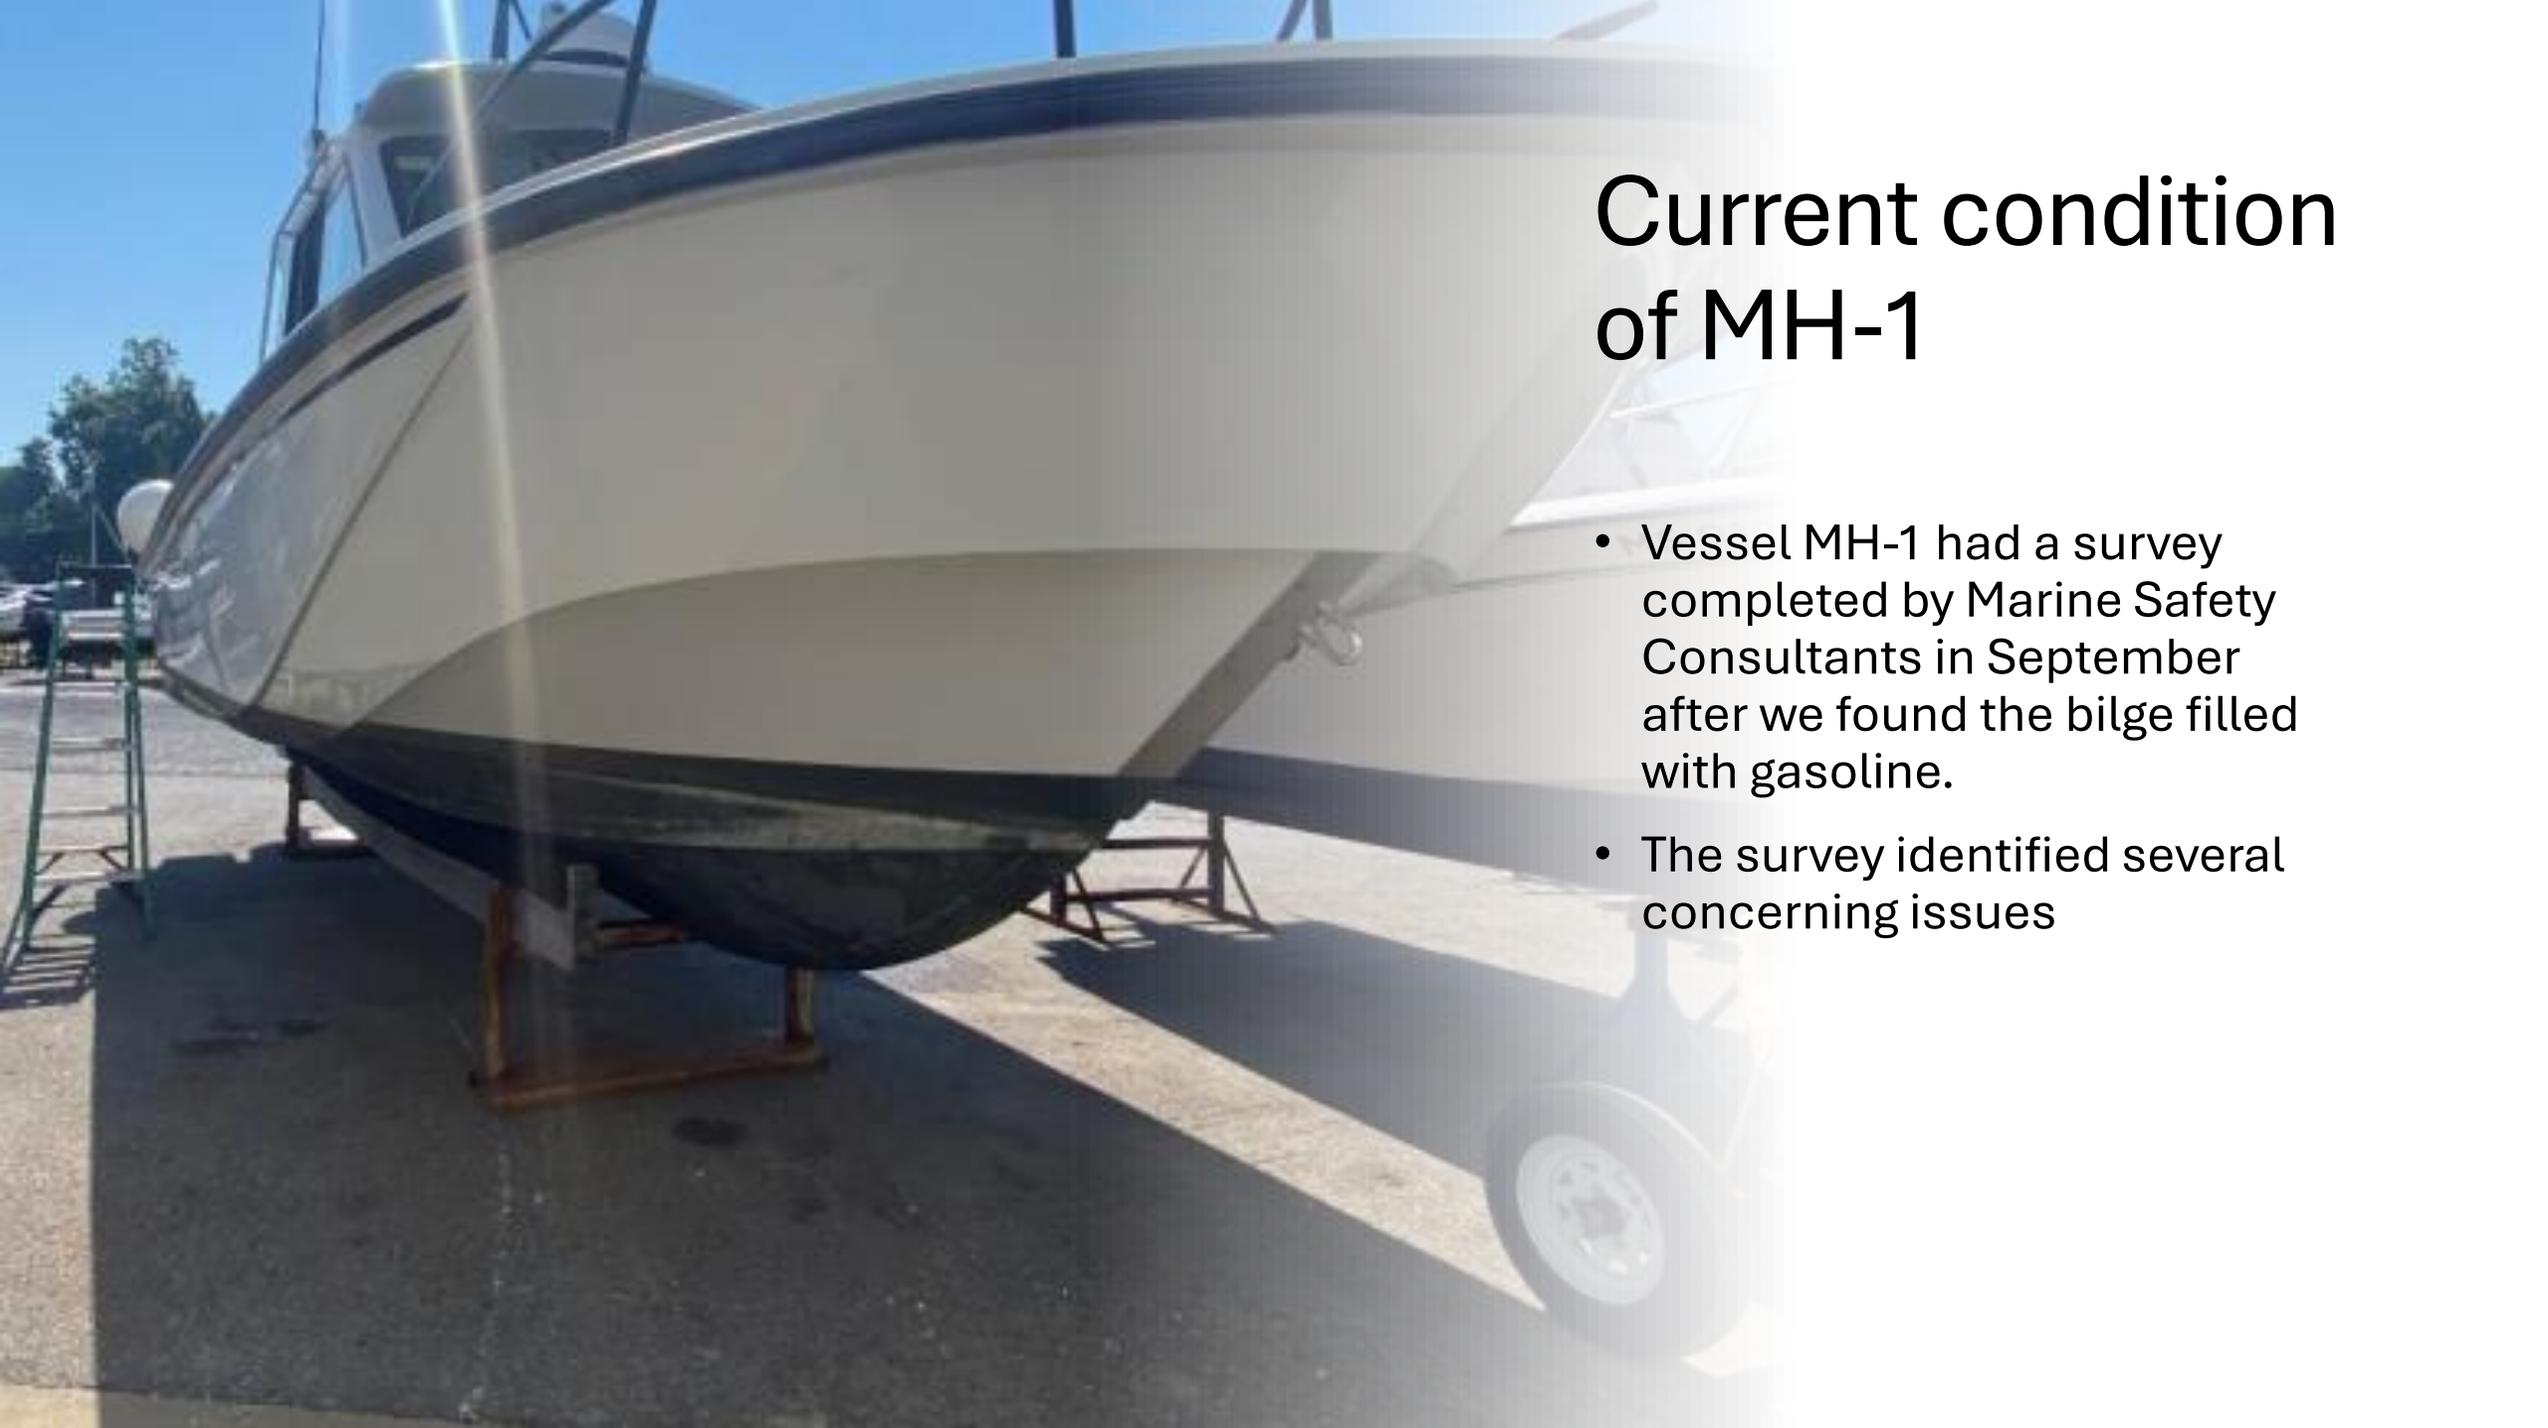
- Vessel MH-1 had a survey completed by Marine Safety Consultants in September after we found the bilge filled with gasoline.
- The survey identified several concerning issues
