# FORM B – BUILDING

**Town/City:** Marion

**Address:** 840 Mill Street

**Historic Name:** Richard E. Bolles House

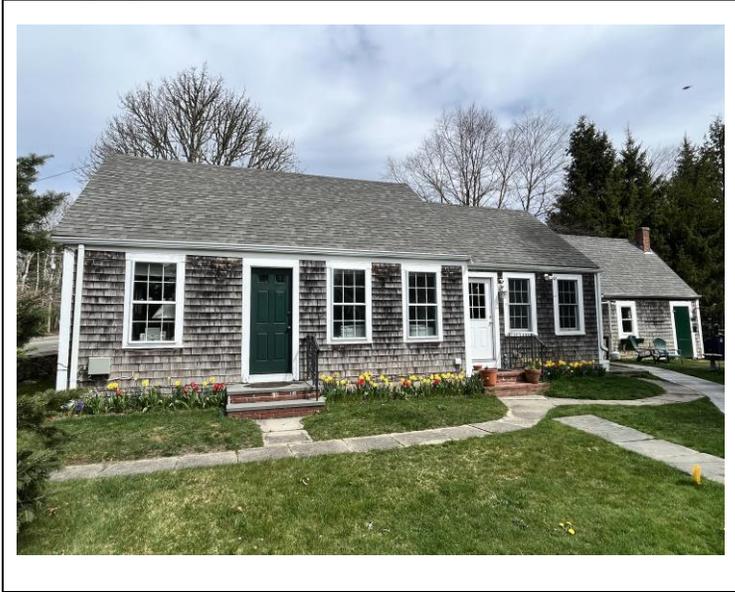
## Photograph

This wood-framed house comprises a two-story, four-bay-by-three-bay, side-gabled main block with three dependencies. The dwelling was constructed ca. 1860 in the Cape form and retains some of its character-defining features. The current owner stated that the main block was originally three bays wide and was expanded at some point to take on its current three-quarter Cape appearance. The three dependencies at the east elevation are set back serially from the façade (south elevation) of the main block. They include an ell and a hyphen connecting the ell to an early barn. The house rises from a stone foundation. The walls are clad in wood shingles and the roof is surfaced with asphalt shingles. A narrow brick chimney rises from just below the roof ridge on the south roof slope of the former barn.

The main block and dependencies are simply trimmed with narrow corner and frieze boards. The windows at the façade at the main block and ell are double-hung, six-over-six sash with flat wood surrounds. The entry at the second-most westerly bay at the main block contains a glass-and-panel door with a narrow flat surround. It fronts a shallow brick stoop and a two-step brick stair leading to a network of walkways connecting the three dependencies and the parking area. The addition of a continuous, flat-roofed dormer at the north roof slope of the main block has significantly compromised its Cape form. There are mulled six-over-six windows and a shed-roofed enclosed entry at the rear elevation.

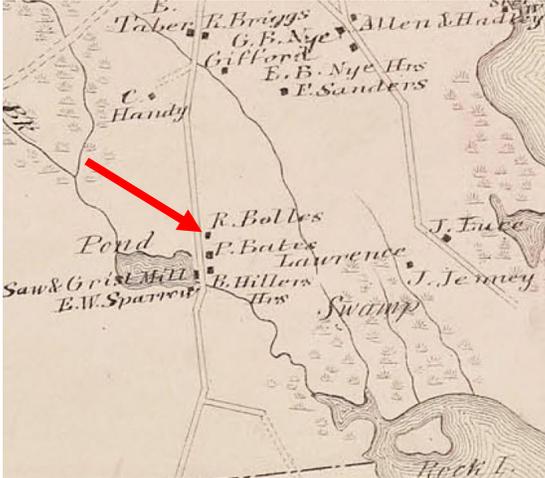
This house is not shown on the 1855 map but appears on the 1879 map just east of the historic Borden's Brook mill pond with R. Bolles identified as the owner. The first recorded conveyance found for the property was its sale in 1860 by Jared Bates (1776-1877) and his wife Jemima Hiller (1803-1875) to Richard Ervin Bolles (1811-1896) and Sophronia Handy Hiller (1819-1903).<sup>1</sup> Jared Bates was a farmer whose house is shown on the 1855 map just south of the future location of the Richard Bolles house; according to the 1860 agricultural census, Jared Bates owned a 50+ acre property. He apparently sold a portion of the farm property to Bolles but the family retained land nearer the mill pond, as seen by the property owned by his son P. [Prince] Bates on the 1879 map.
