Year 5 Annual Report
Massachusetts Small MS4 General Permit
Reporting Period: July 1, 2022-June 30, 2023

Below are the observations made for 114 storm drain systems. Each drain system is referenced by the facility ID of the outfall pipe.

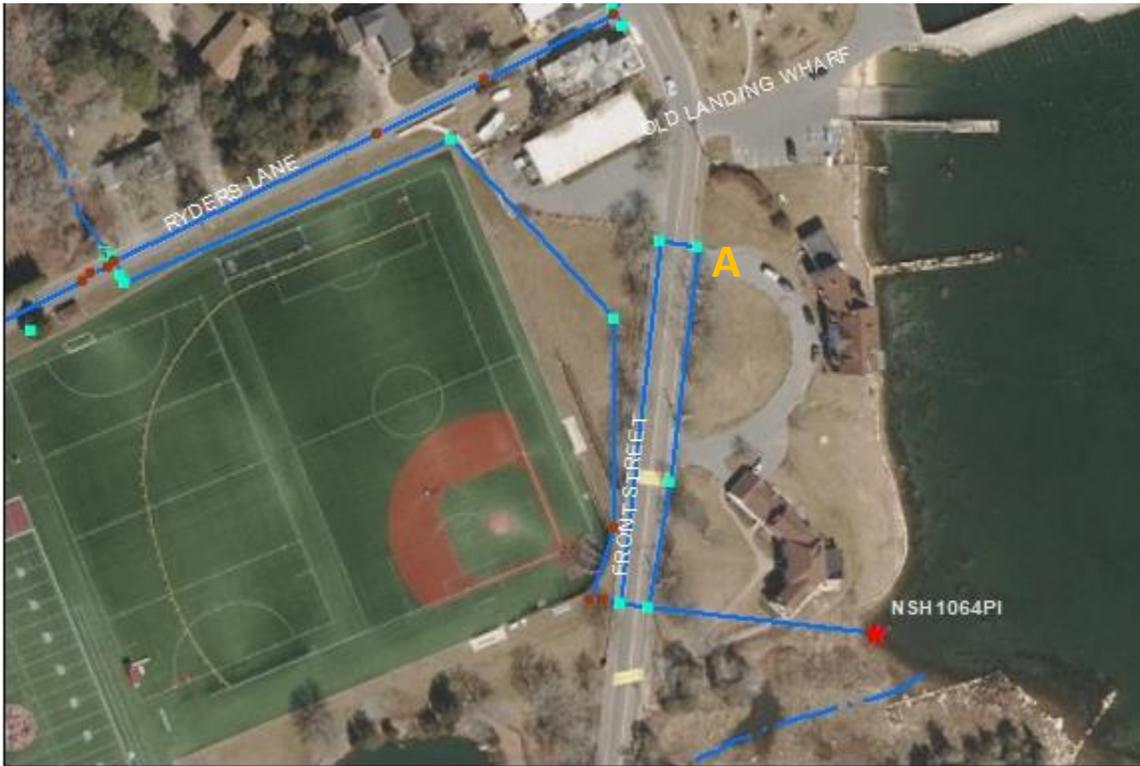
NSH1064PI- Front Street: No issues found. The NSH1064PI network used to traverse the ball field but has been rerouted around the field. At location A the catch basin is covered with a silt fence.

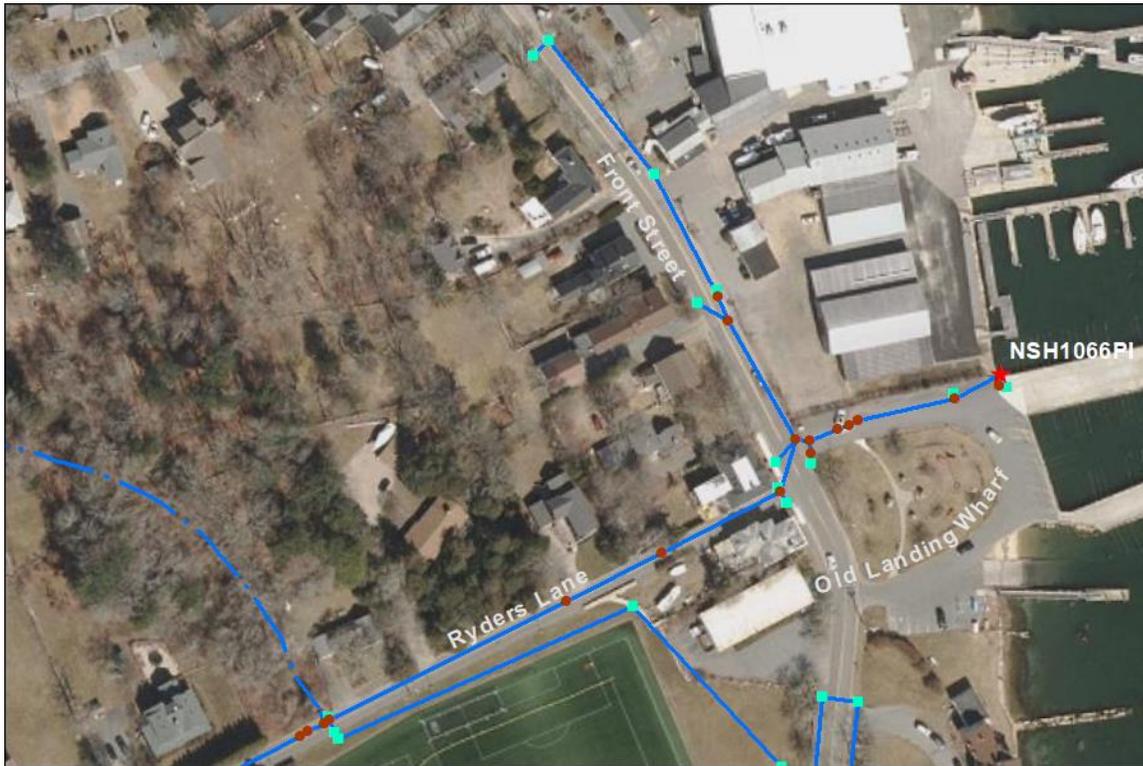
NSH1066PI (1/2) – Front Street and Ryders Lane: No issues found. This system was installed in 2013 to re-route the stream North of Ryders Lane from traversing the ball field and directs it to a treatment system at Old Landing Wharf.

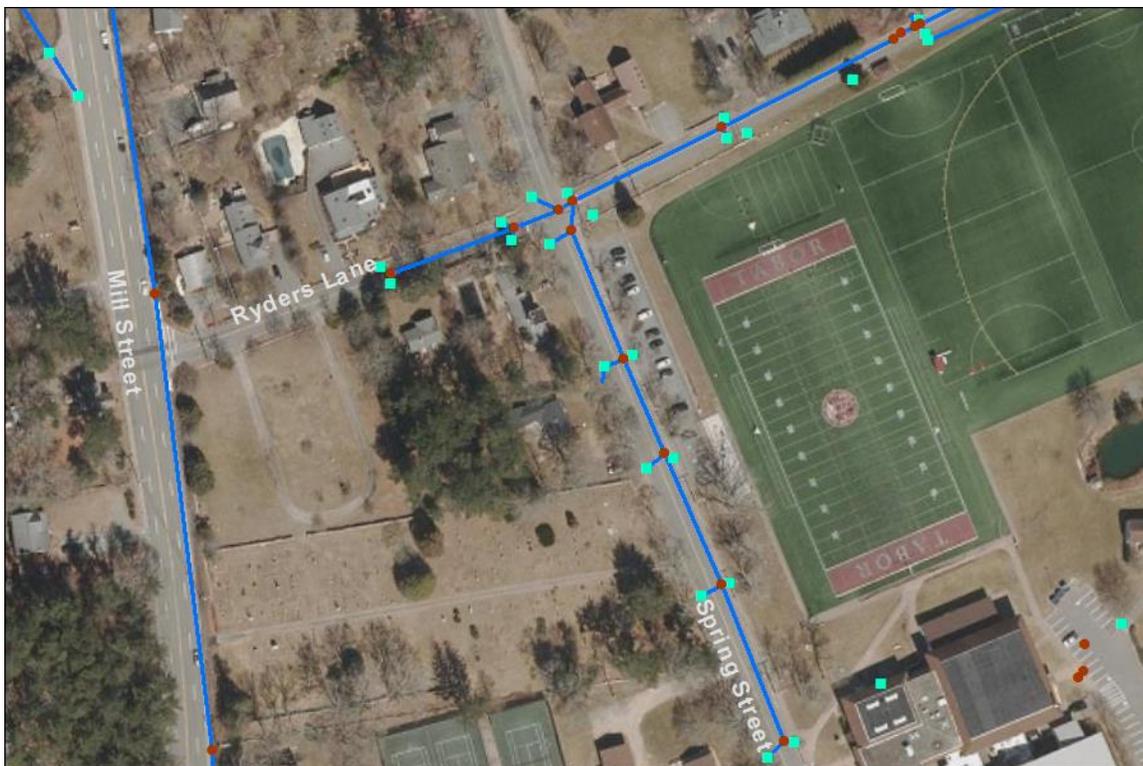
NSH1066PI (2/2) – Ryders Lane and Spring Street: No issues found.

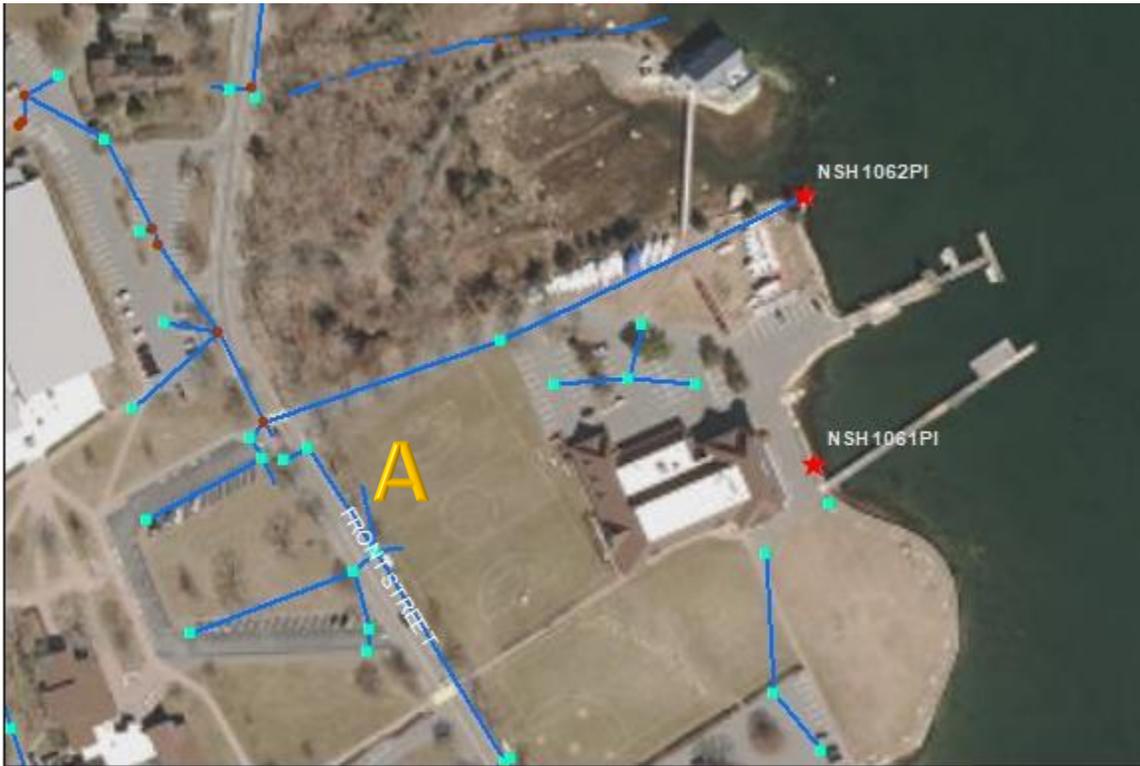
NSH1062PI and NSH1061PI – Front Street: No issues found. The catchbasins at the sailing center do not appear to connect to the Town’s network. At point A, a pipe exits the catchbasin in the direction of a wetland. The wetland fills with water during rain events. Extremely likely there is an outfall buried there that is fully functioning. However, it could not be confirmed.

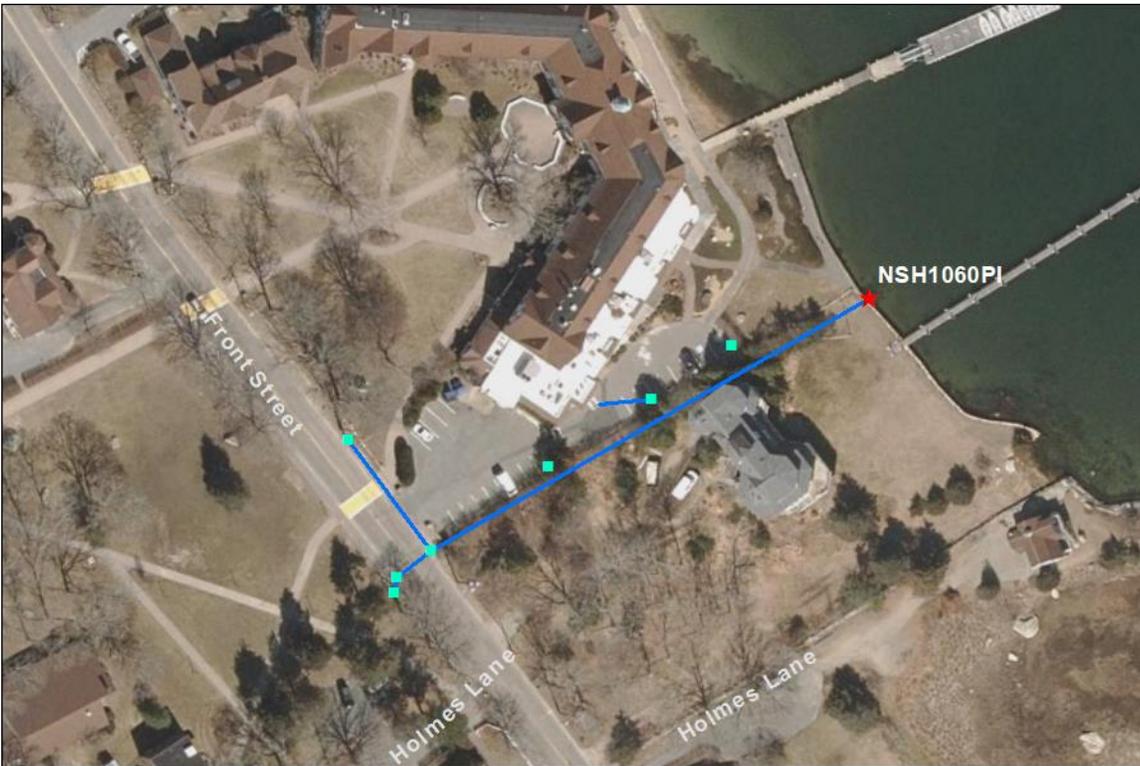
NSH1060PI – Front Street: No issues found. The catch basins in the dining hall parking lot do not connect to this network. They appear to connect to the grease trap which drains to the sewer system causing inflow.

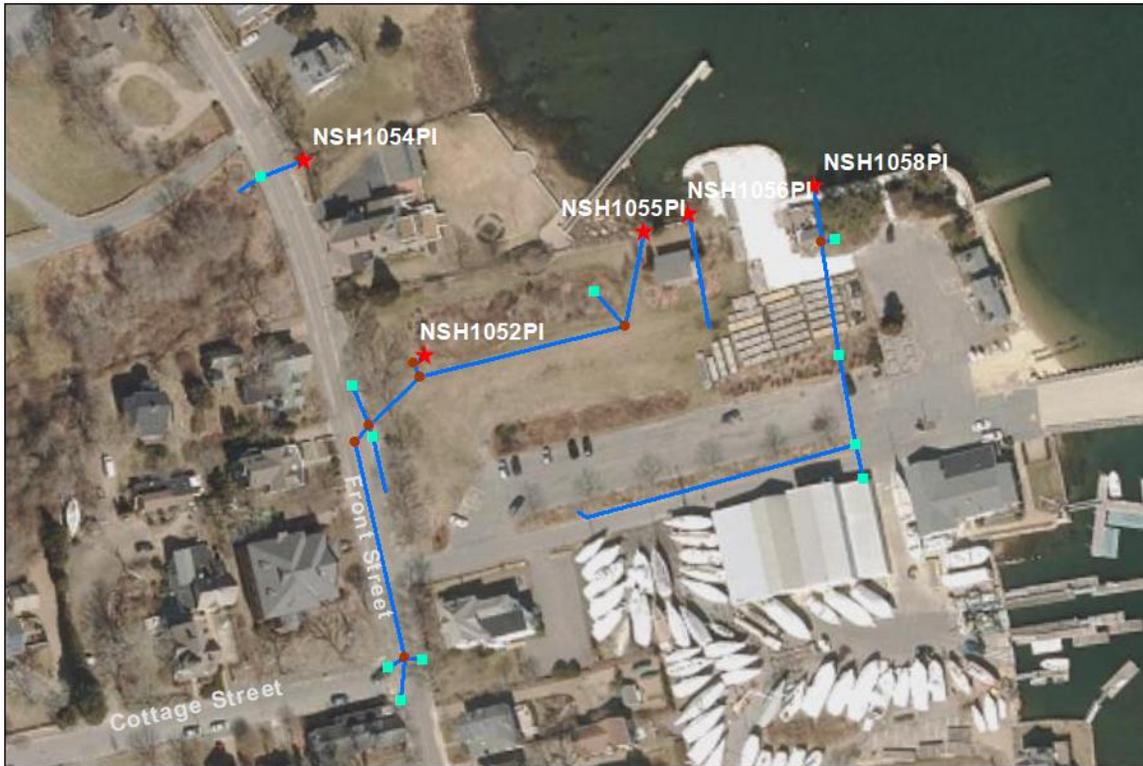
NSH1054PI, NSH1052PI, NSH1055PI, NSH1056PI, and NSH1058PI – Front Street: No issues found. NSH1052PI enters an artificial wetland with a manifold and then discharges to NSH1055PI. NSH1056PI was previously determined to be an abandoned outfall servicing no structures.

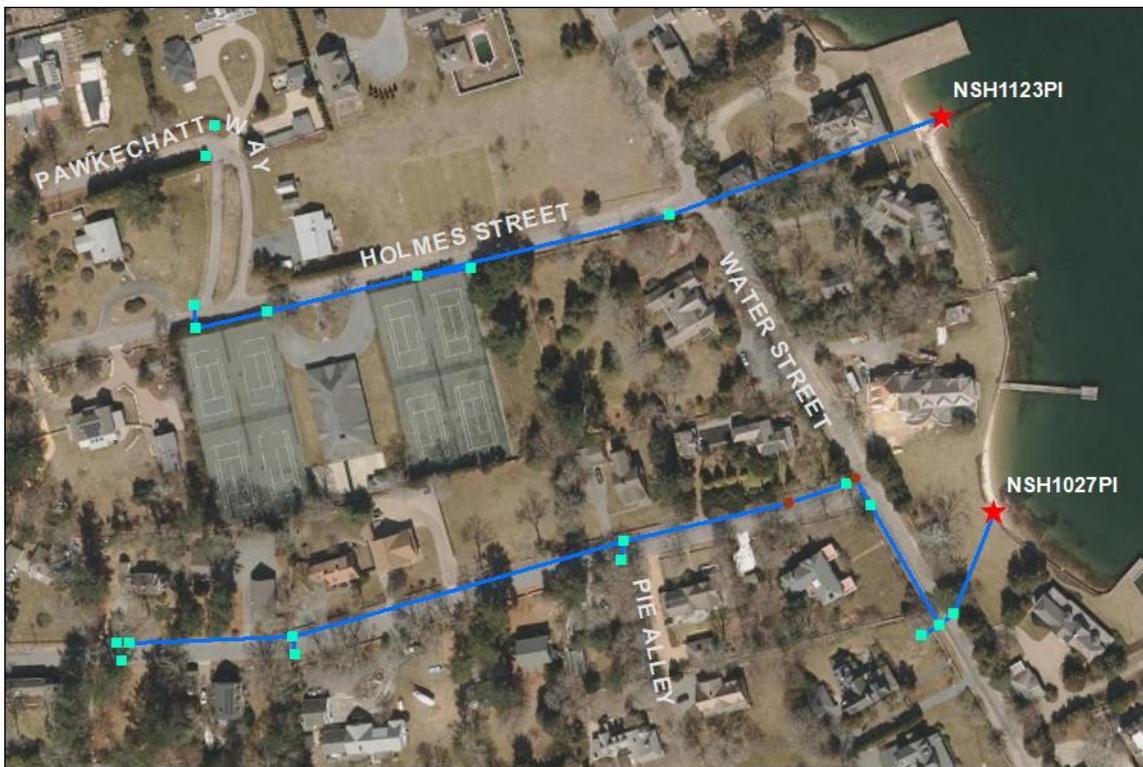
NSH1123PI – Holmes Street: No significant issues found; newly documented outfall; this is a very old network with various structures poorly added; excessive pet waste in area. Community outreach is recommended.

NSH1027PI – Allen Street: No significant issues found; this is also an old network with excessive pet waste in area. Community outreach is suggested.

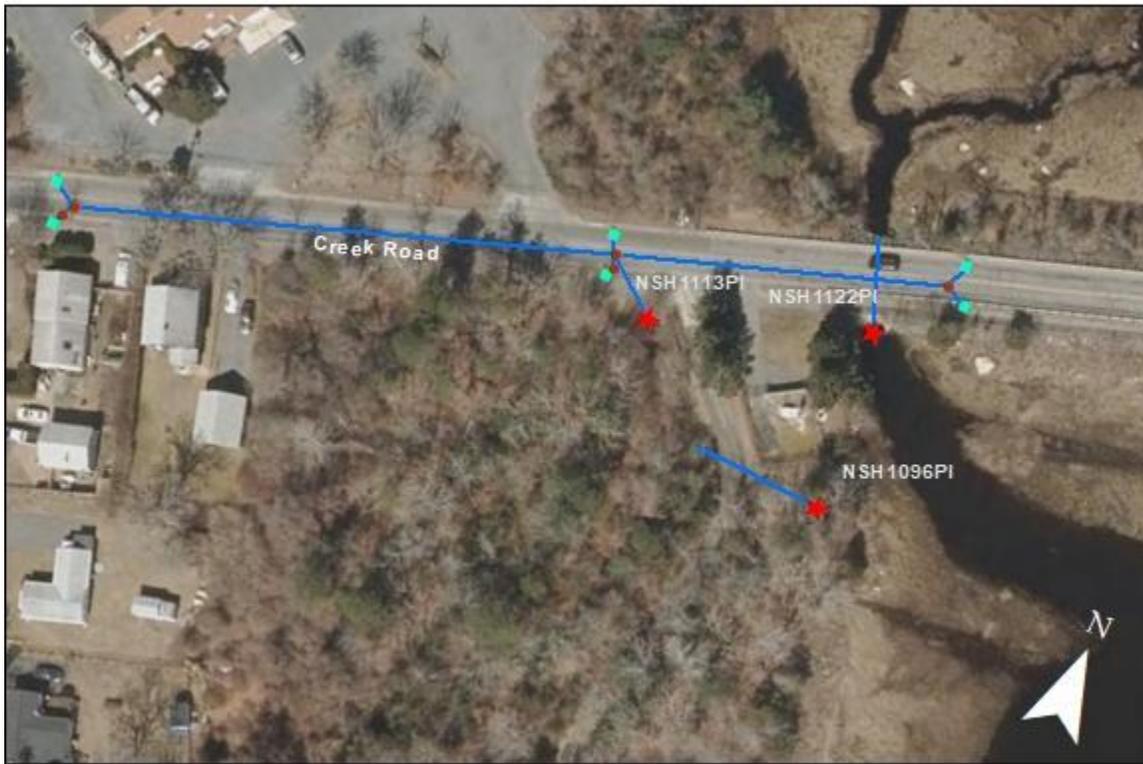
NSH1113PI, NSH1122PI, and NSH1096PI- Creek Road: No issues found.

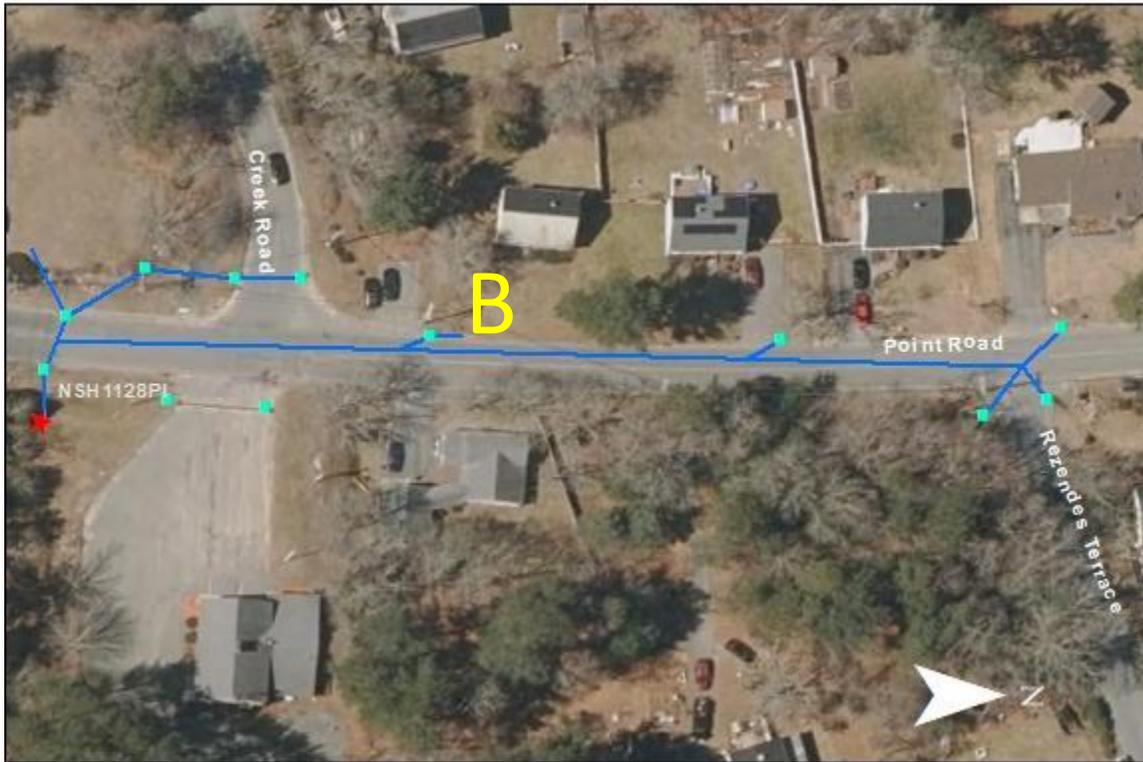
NSH1128PI-Point Road and Creek Road: No issues found. At point B a 12" pipe enters the catchbasin. Its origin is unknown.

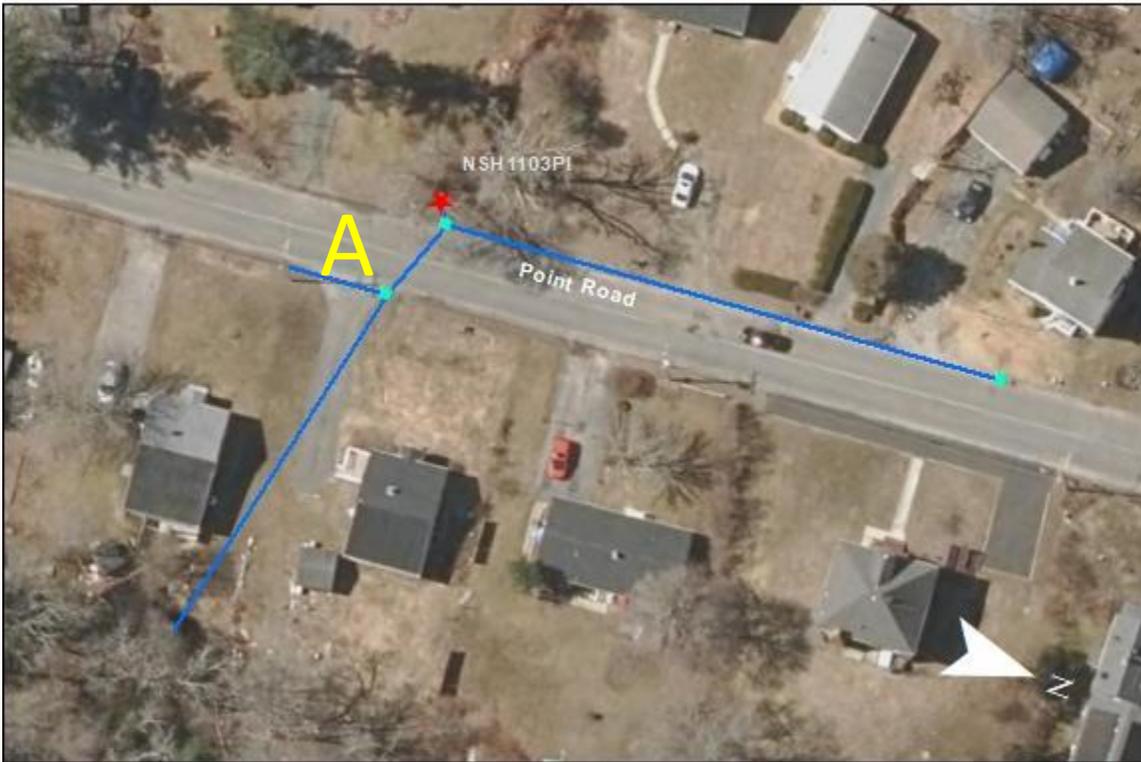
NSH1103PI- Point Road: No issues found. Pipe enters catchbasin at point A. Origin of pipe unknown.

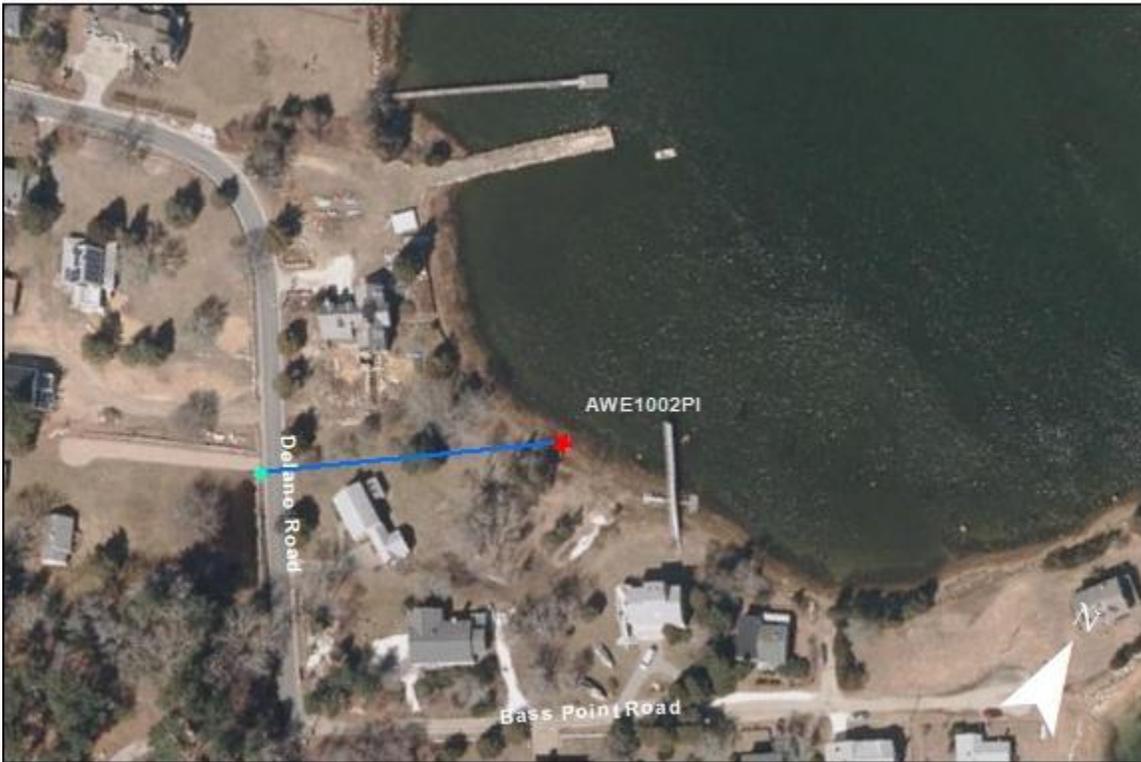
AWE1002PI- Delano Road: No issues found.

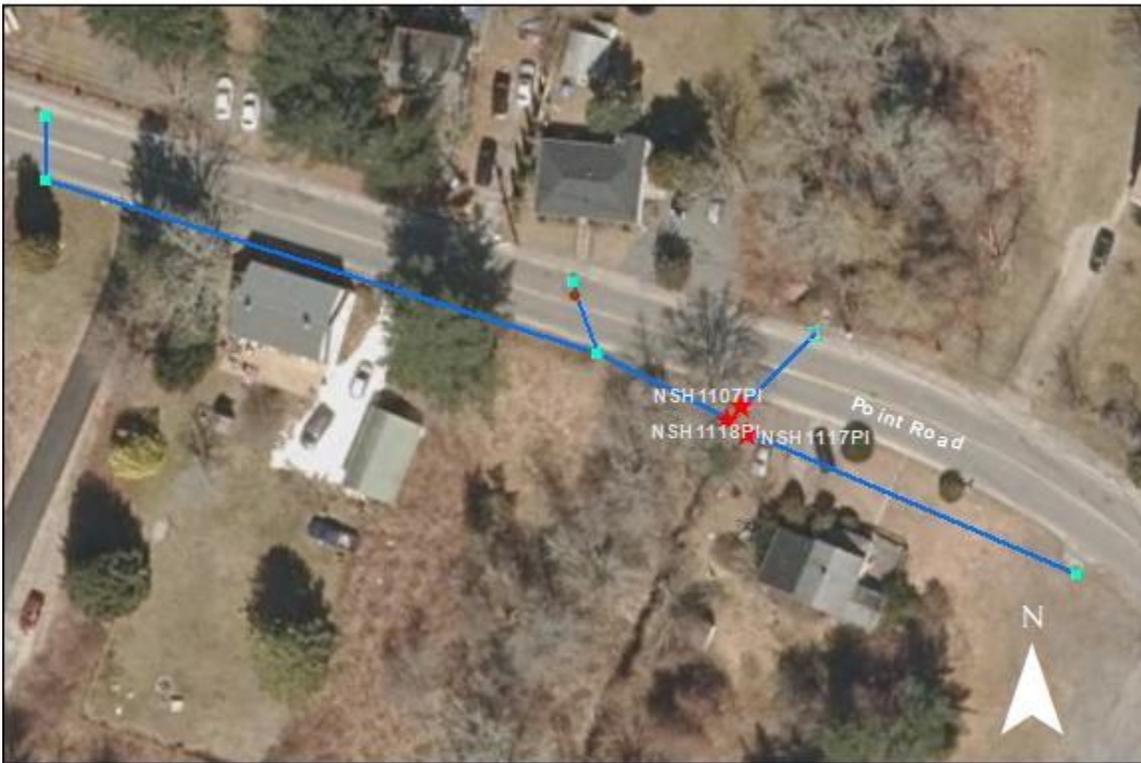
NSH1107PI, NSH1118PI, and NSH1117PI- Point Road: No issues found.

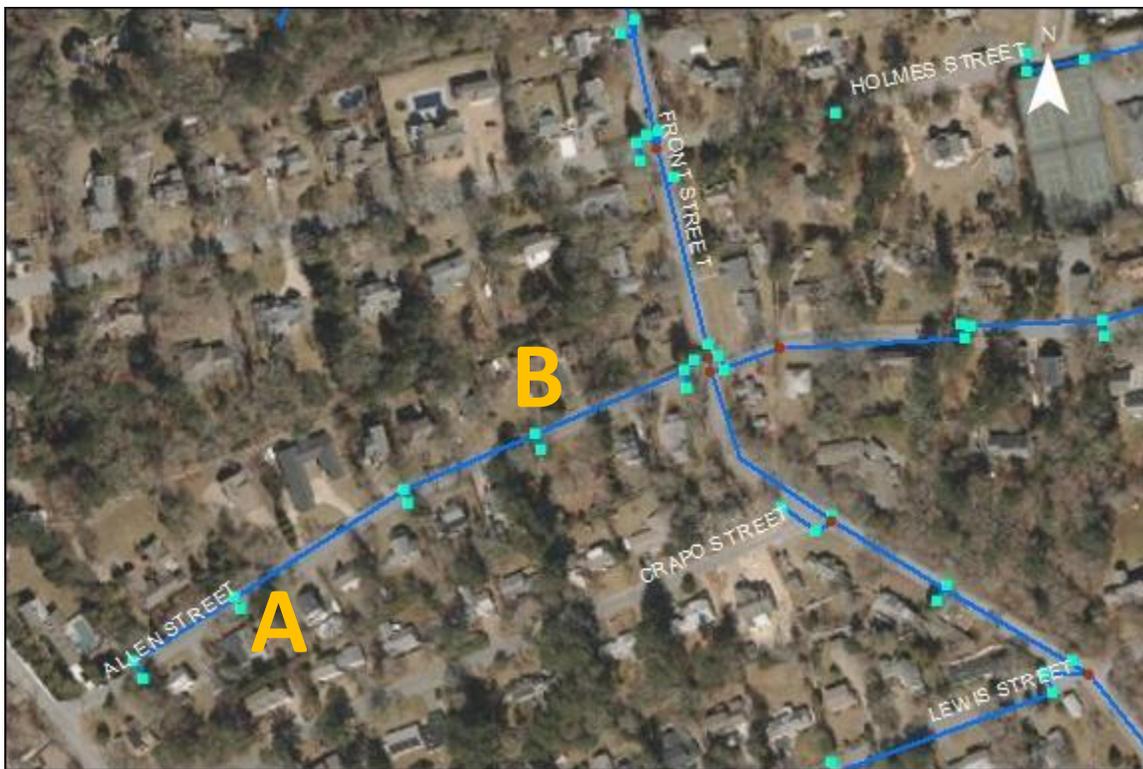
NSH1019PI (2/3)- Front Street: At point A and B the catchbasins have begun to sink. Both are in need of repair. Preventative maintenance is recommended.

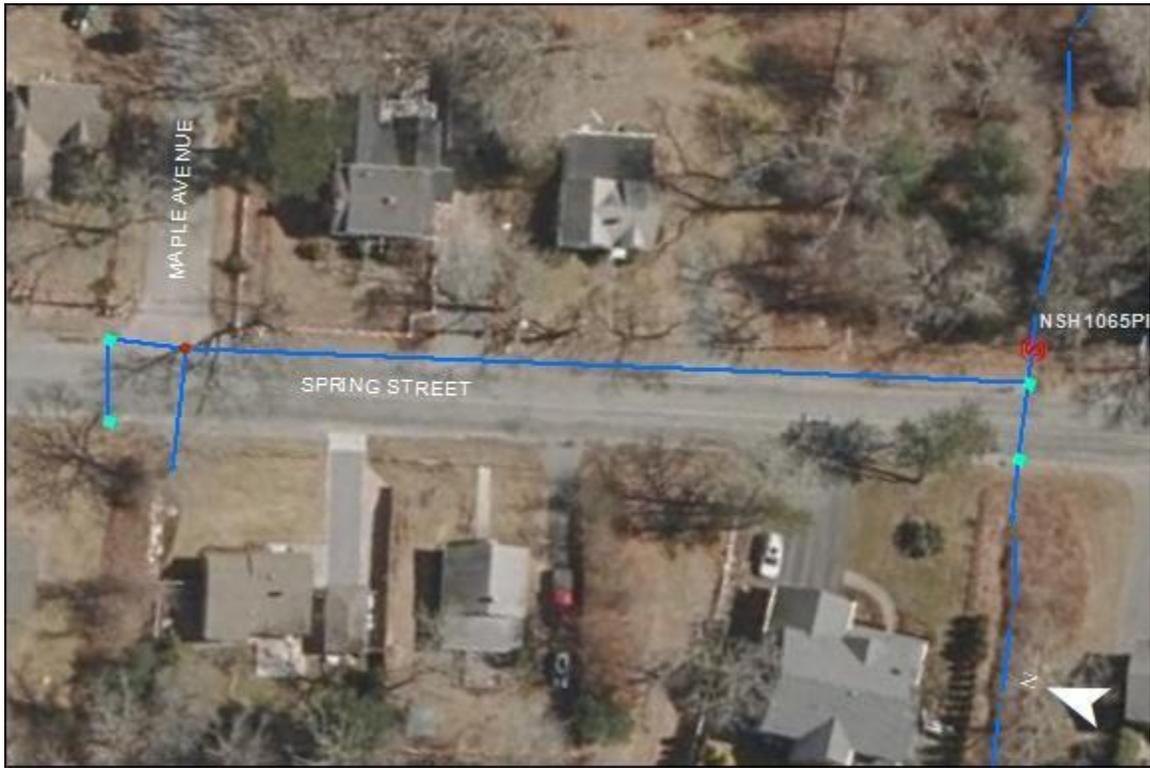
NSH1065PI- Spring Street: No issues found.

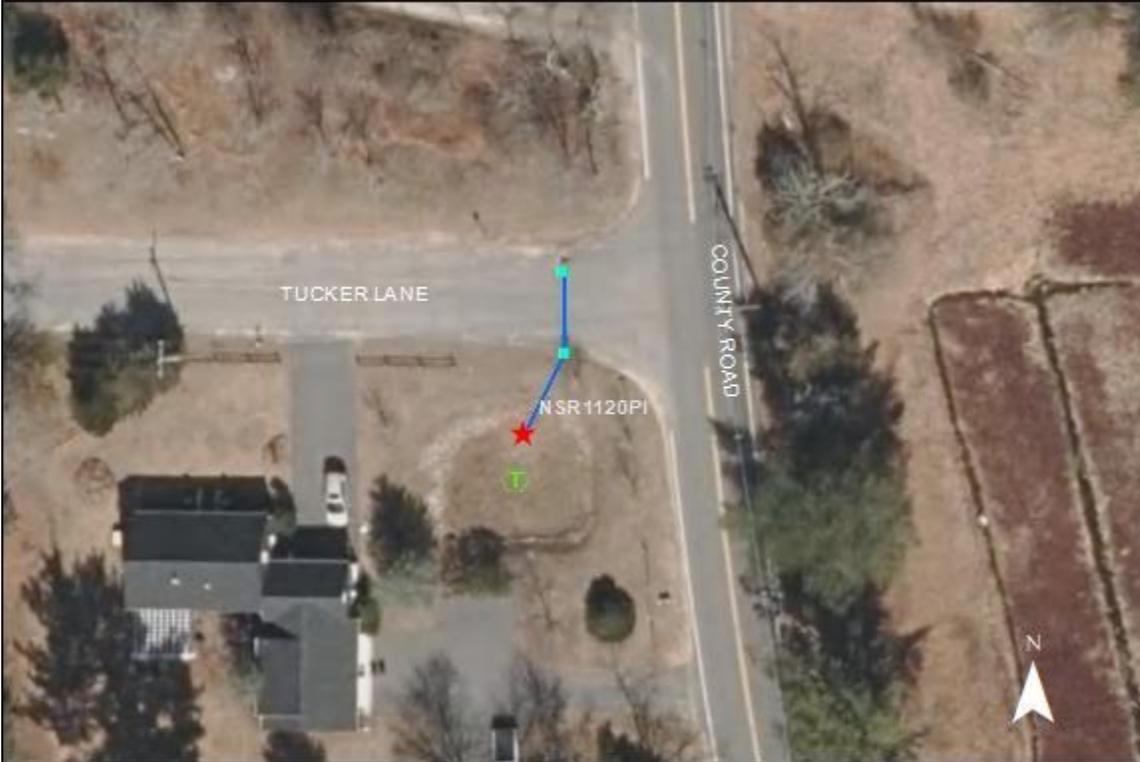
NSR1120PI- Tucker Lane: No issues found.

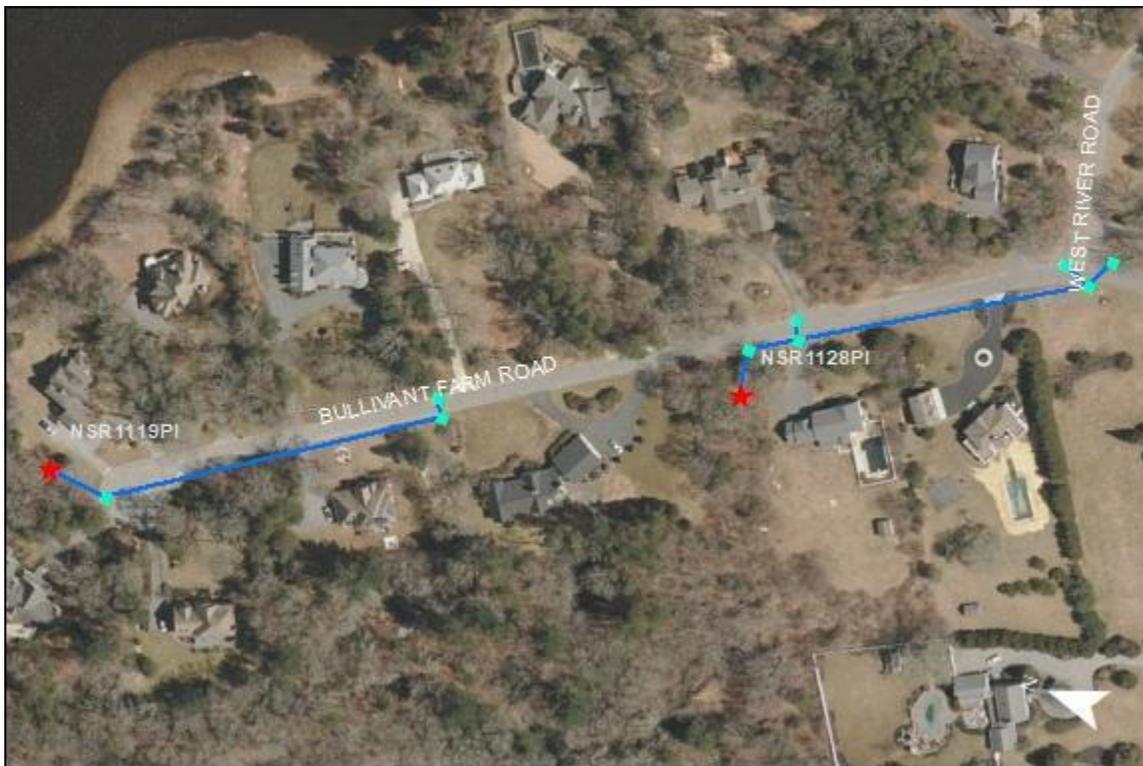
NSR1119PI and NSR1128PI- Bullivant Farm Road: No issues found.

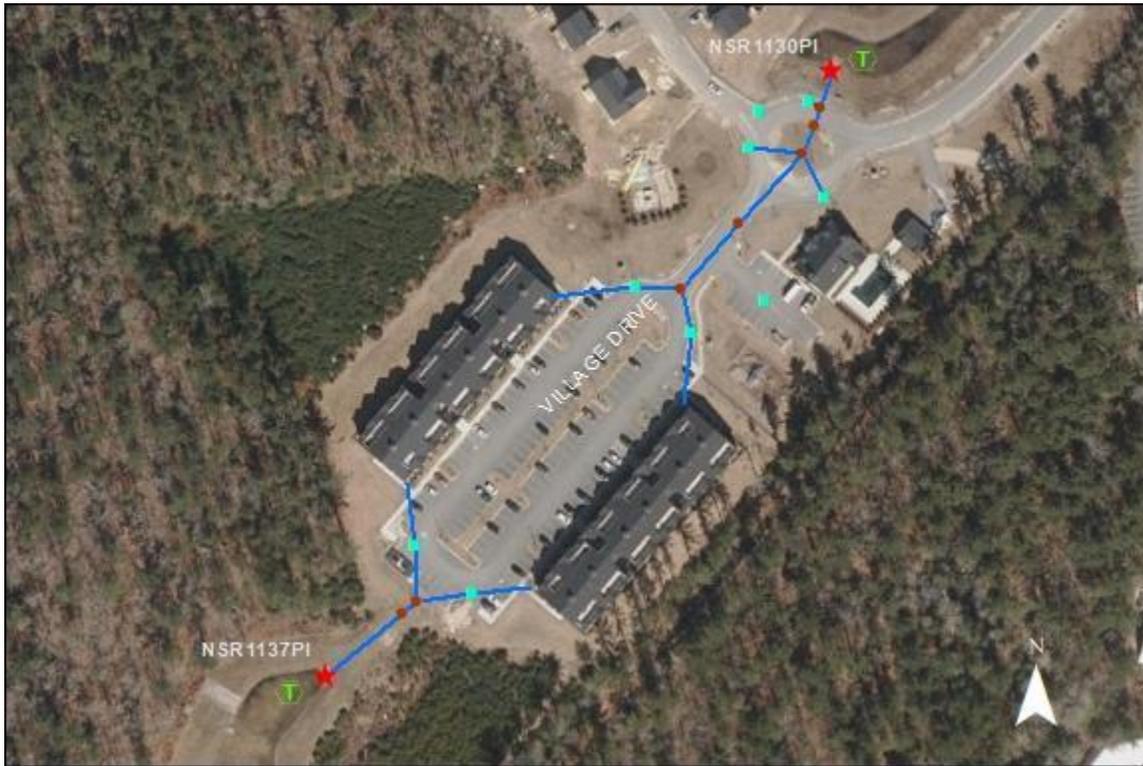
NSR1137PI and NSR1130PI- Village Drive: No issues found.

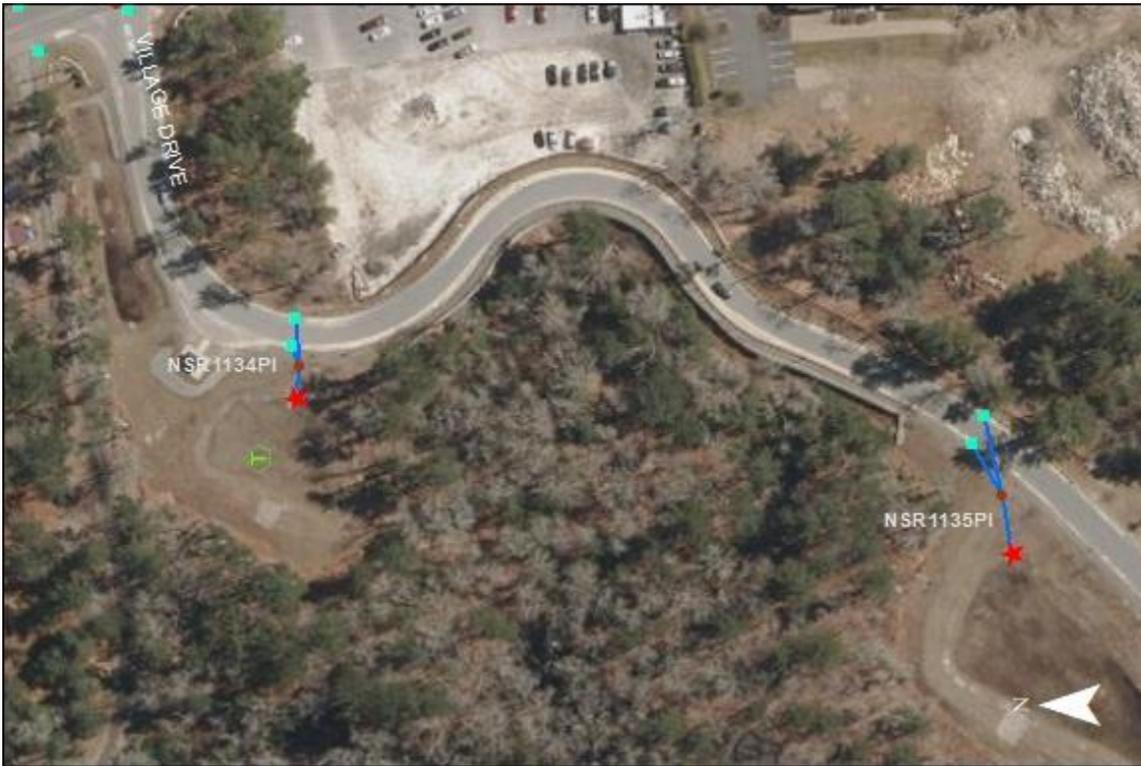
NSR1134PI and NSR1135PI- Village Drive: No issues found.

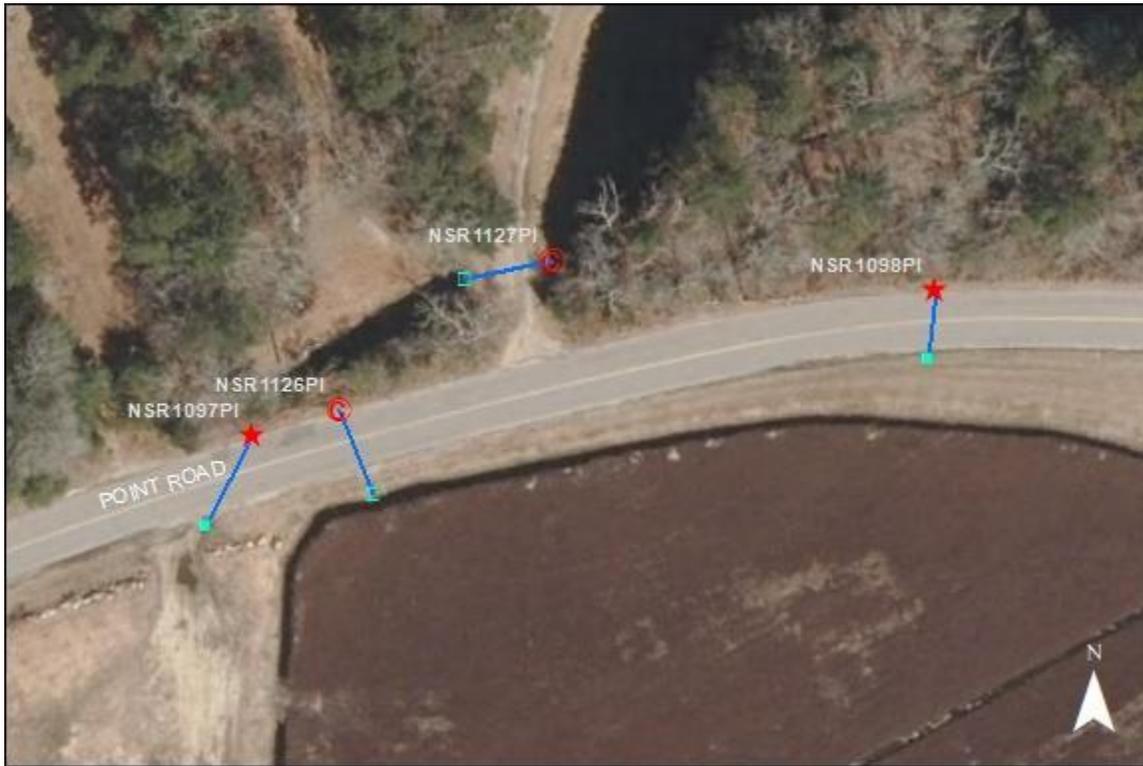
NSR1098PI, NSR1127PI, NSR1126PI, and NSR1097PI- Point Road: No issues found.

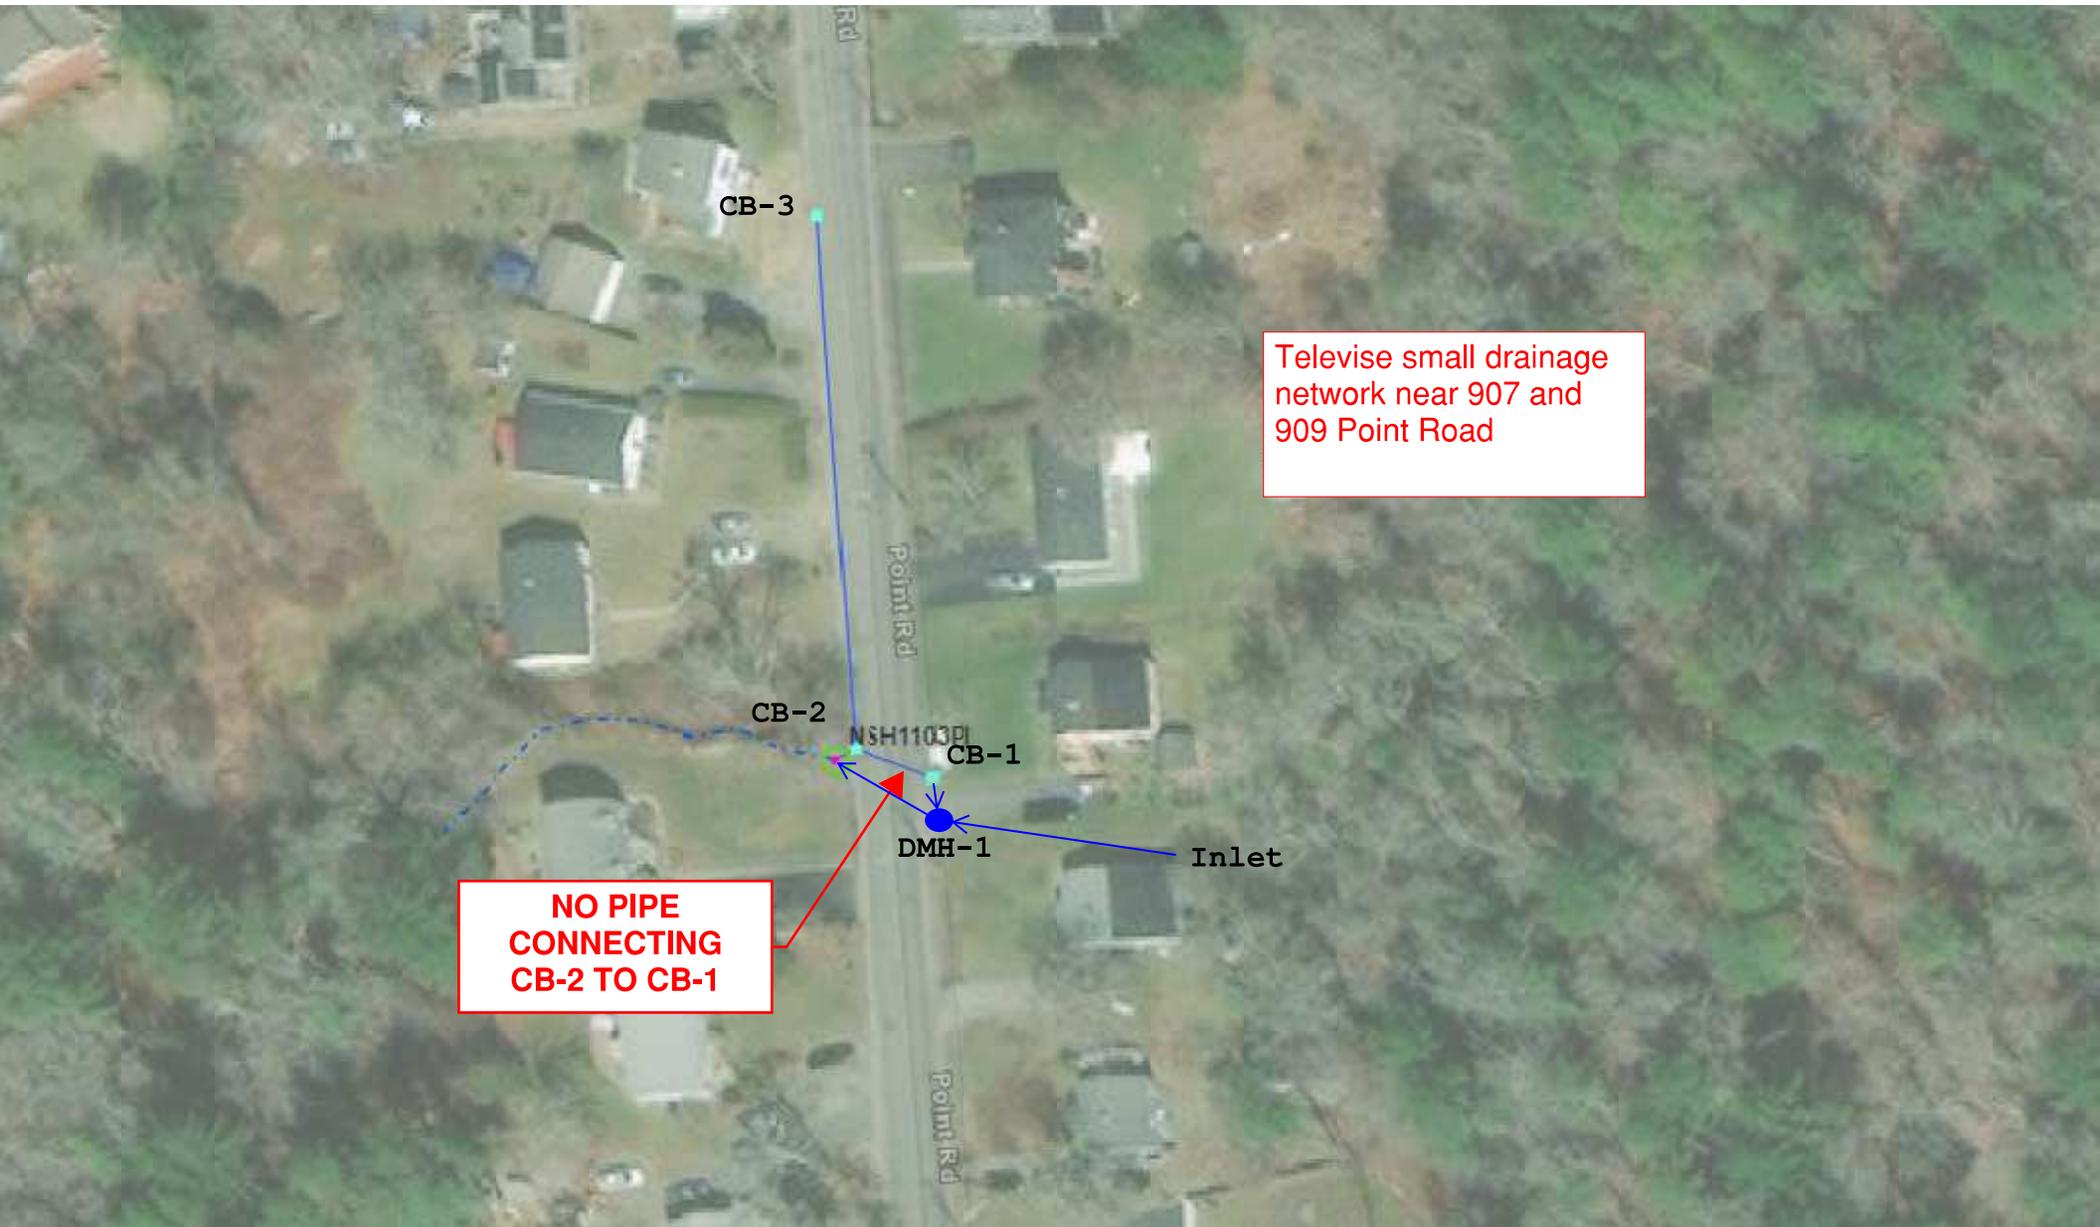
Televise small drainage network near 907 and 909 Point Road

Under the direction and supervision of Weston & Sampson, Truax Corporation investigated the drainage network area near 907 and 909 Point Road. Due to previous access issues the town was unclear of the condition of the drains in this area. In total, four (4) segments were investigated, and the information is as follows:

NO PIPE CONNECTING CB-2 TO CB-1
