Year 5 Annual Report
Massachusetts Small MS4 General Permit
Reporting Period: July 1, 2022-June 30, 2023

Below are the observations made for 114 storm drain systems. Each drain system is referenced by the facility ID of the outfall pipe.

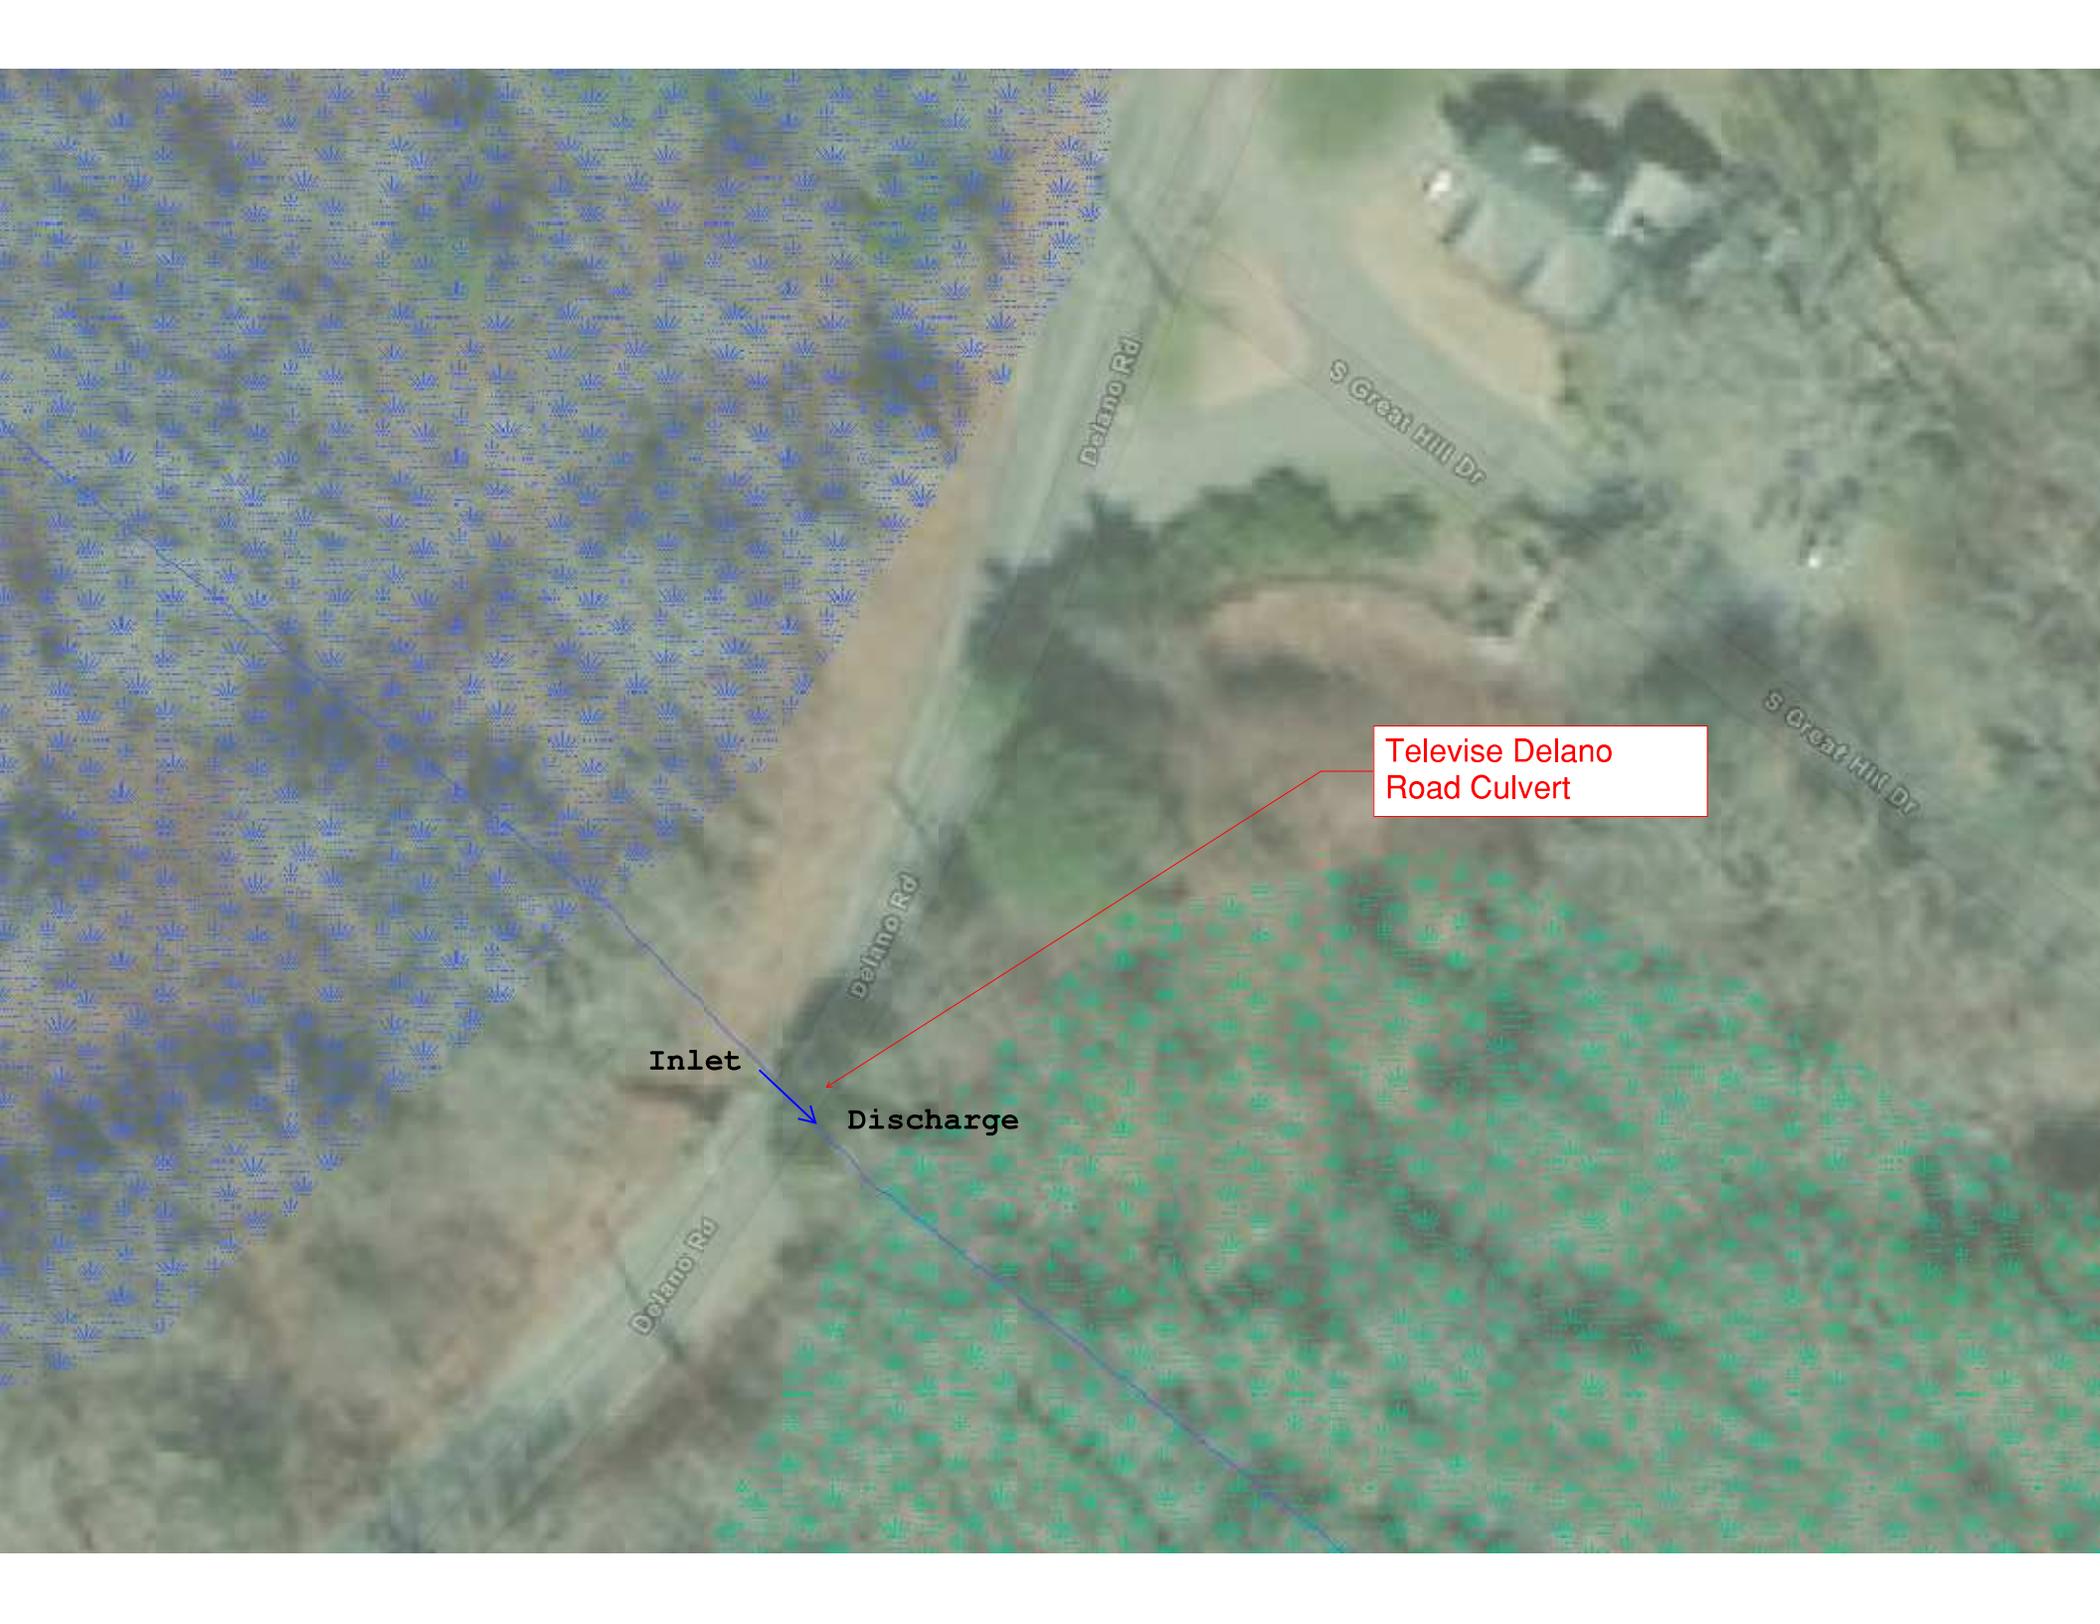
Televise Delano
Road Culvert

- 0+00 – Partial Collapse – 9 o'clock - Begins
- 0+00 – Deterioration – 4 o'clock to 8 o'clock
- 0+11 – Partial Collapse - 9 o'clock - Ends

- 0+13 – Deterioration - 4 o'clock to 8 o'clock – Ends
- 0+28 – Water Main Visible
- 0+30 – Survey Abandoned - Discharge

Recommend replacement of box culvert and relocate existing water main to flow below final elevation of box culvert.

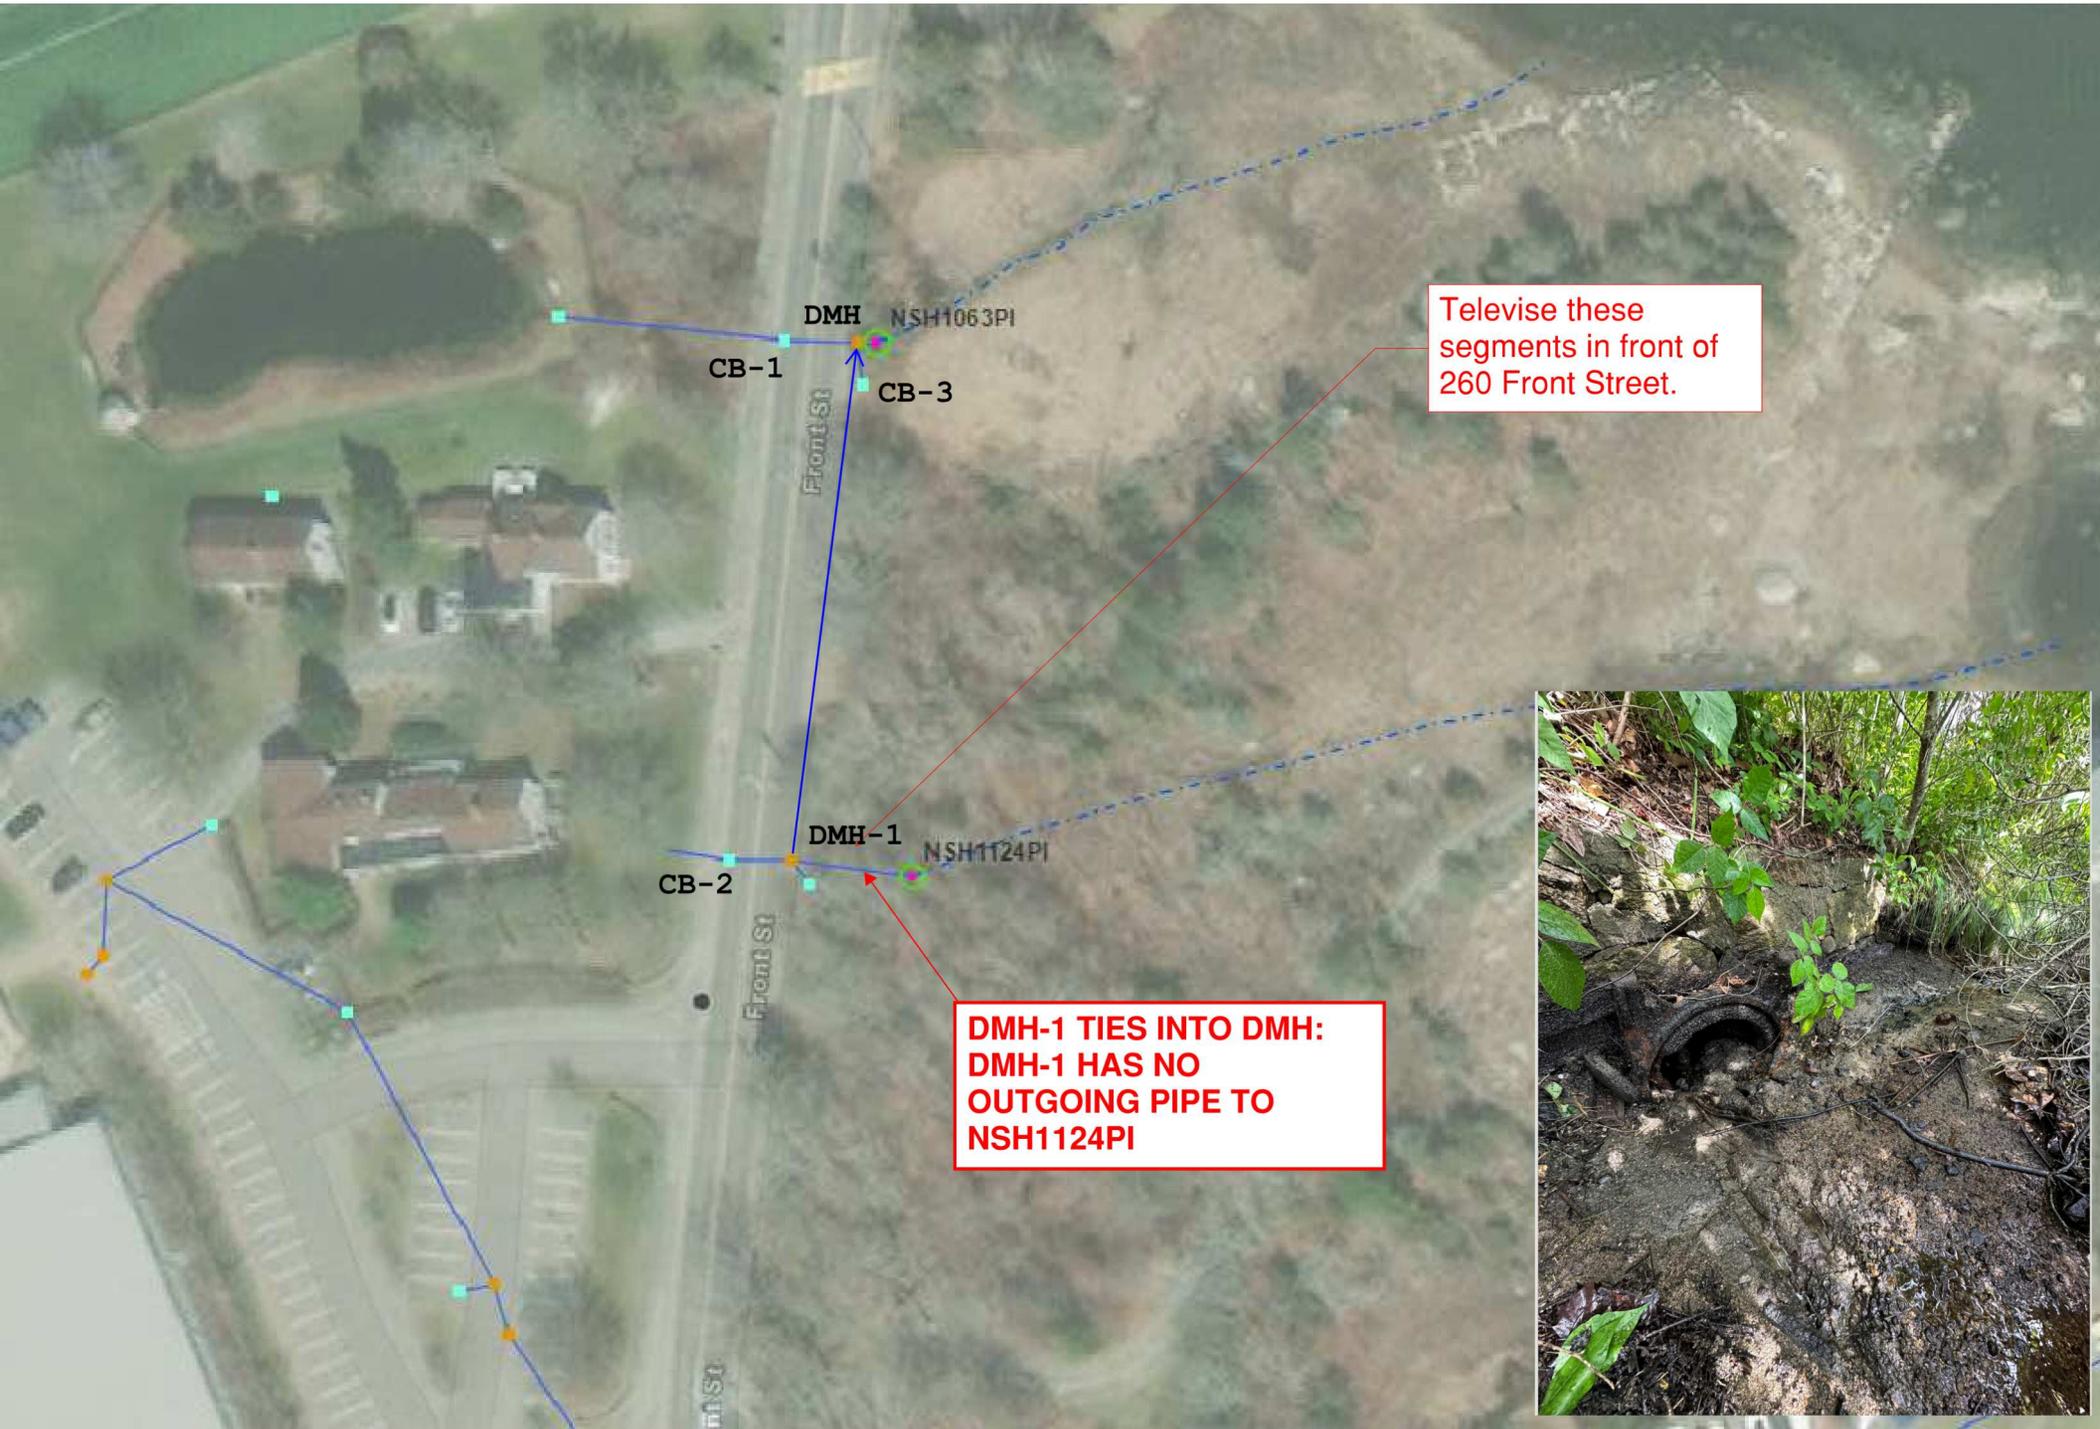
Televise these segments in front of 260 Front Street.

- 0+02 – Surface Corrosion – Throughout
- 0+02 – Roots – Light – Throughout
- 0+31 – Hole – Large – Rocks and Soil Visible
- 0+91 – Hole – Minor Puncture
- 0+97 – Offset Joint – Minor
- 1+15 – Offset Joint – Medium
- 1+18 – Sag – Medium
- 1+37 – Broken – Joint
- 1+90 – Offset Joint – Minor
- 1+92 – DMH

DMH-1 TIES INTO DMH:
DMH-1 HAS NO
OUTGOING PIPE TO
NSH1124PI

- o Recommend heavy cleaning to remove roots and debris between DMH-1 and CB-2.
- o Recommend clearing area around NSH1063PI as it appears debris buildup could impede flow from the catch basins on Front St.
- o In addition, recommend open cut point repair approximately 8 LF upstream of DMH toward CB-1 to repair severe offset joint. It appears this offset may have been constructed with this alignment change/offset due to other utility conflicts. Therefore, that would need to be investigated prior to construction.
- o Another open cut repair is recommended 0+31 downstream of DMH-1 toward DMH to repair a large hole in the drain pipe with rocks and soil visible.

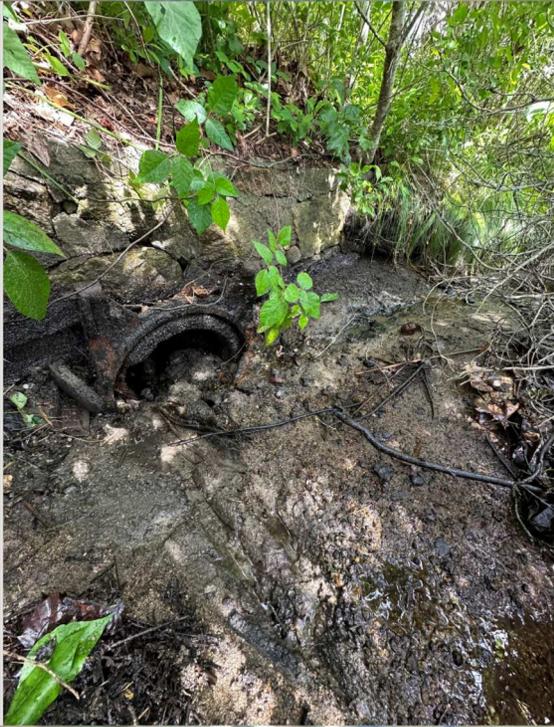
Pipe to Outfall NSH1098PI appears to be clogged. Attempt to clean and clear the backup.

Recommend clearing area around NSH1098PI as it appears debris buildup could impede flow from the catch basins on Creek Rd. In addition, recommend replacement of drain from Discharge to Inlet due to collapse identified during the investigation.
